TECHNICAL SERVICE BULLETIN

MODEL XJ6 SERIES III 4.2

SUBJECT: AIR FLOW METER MOD

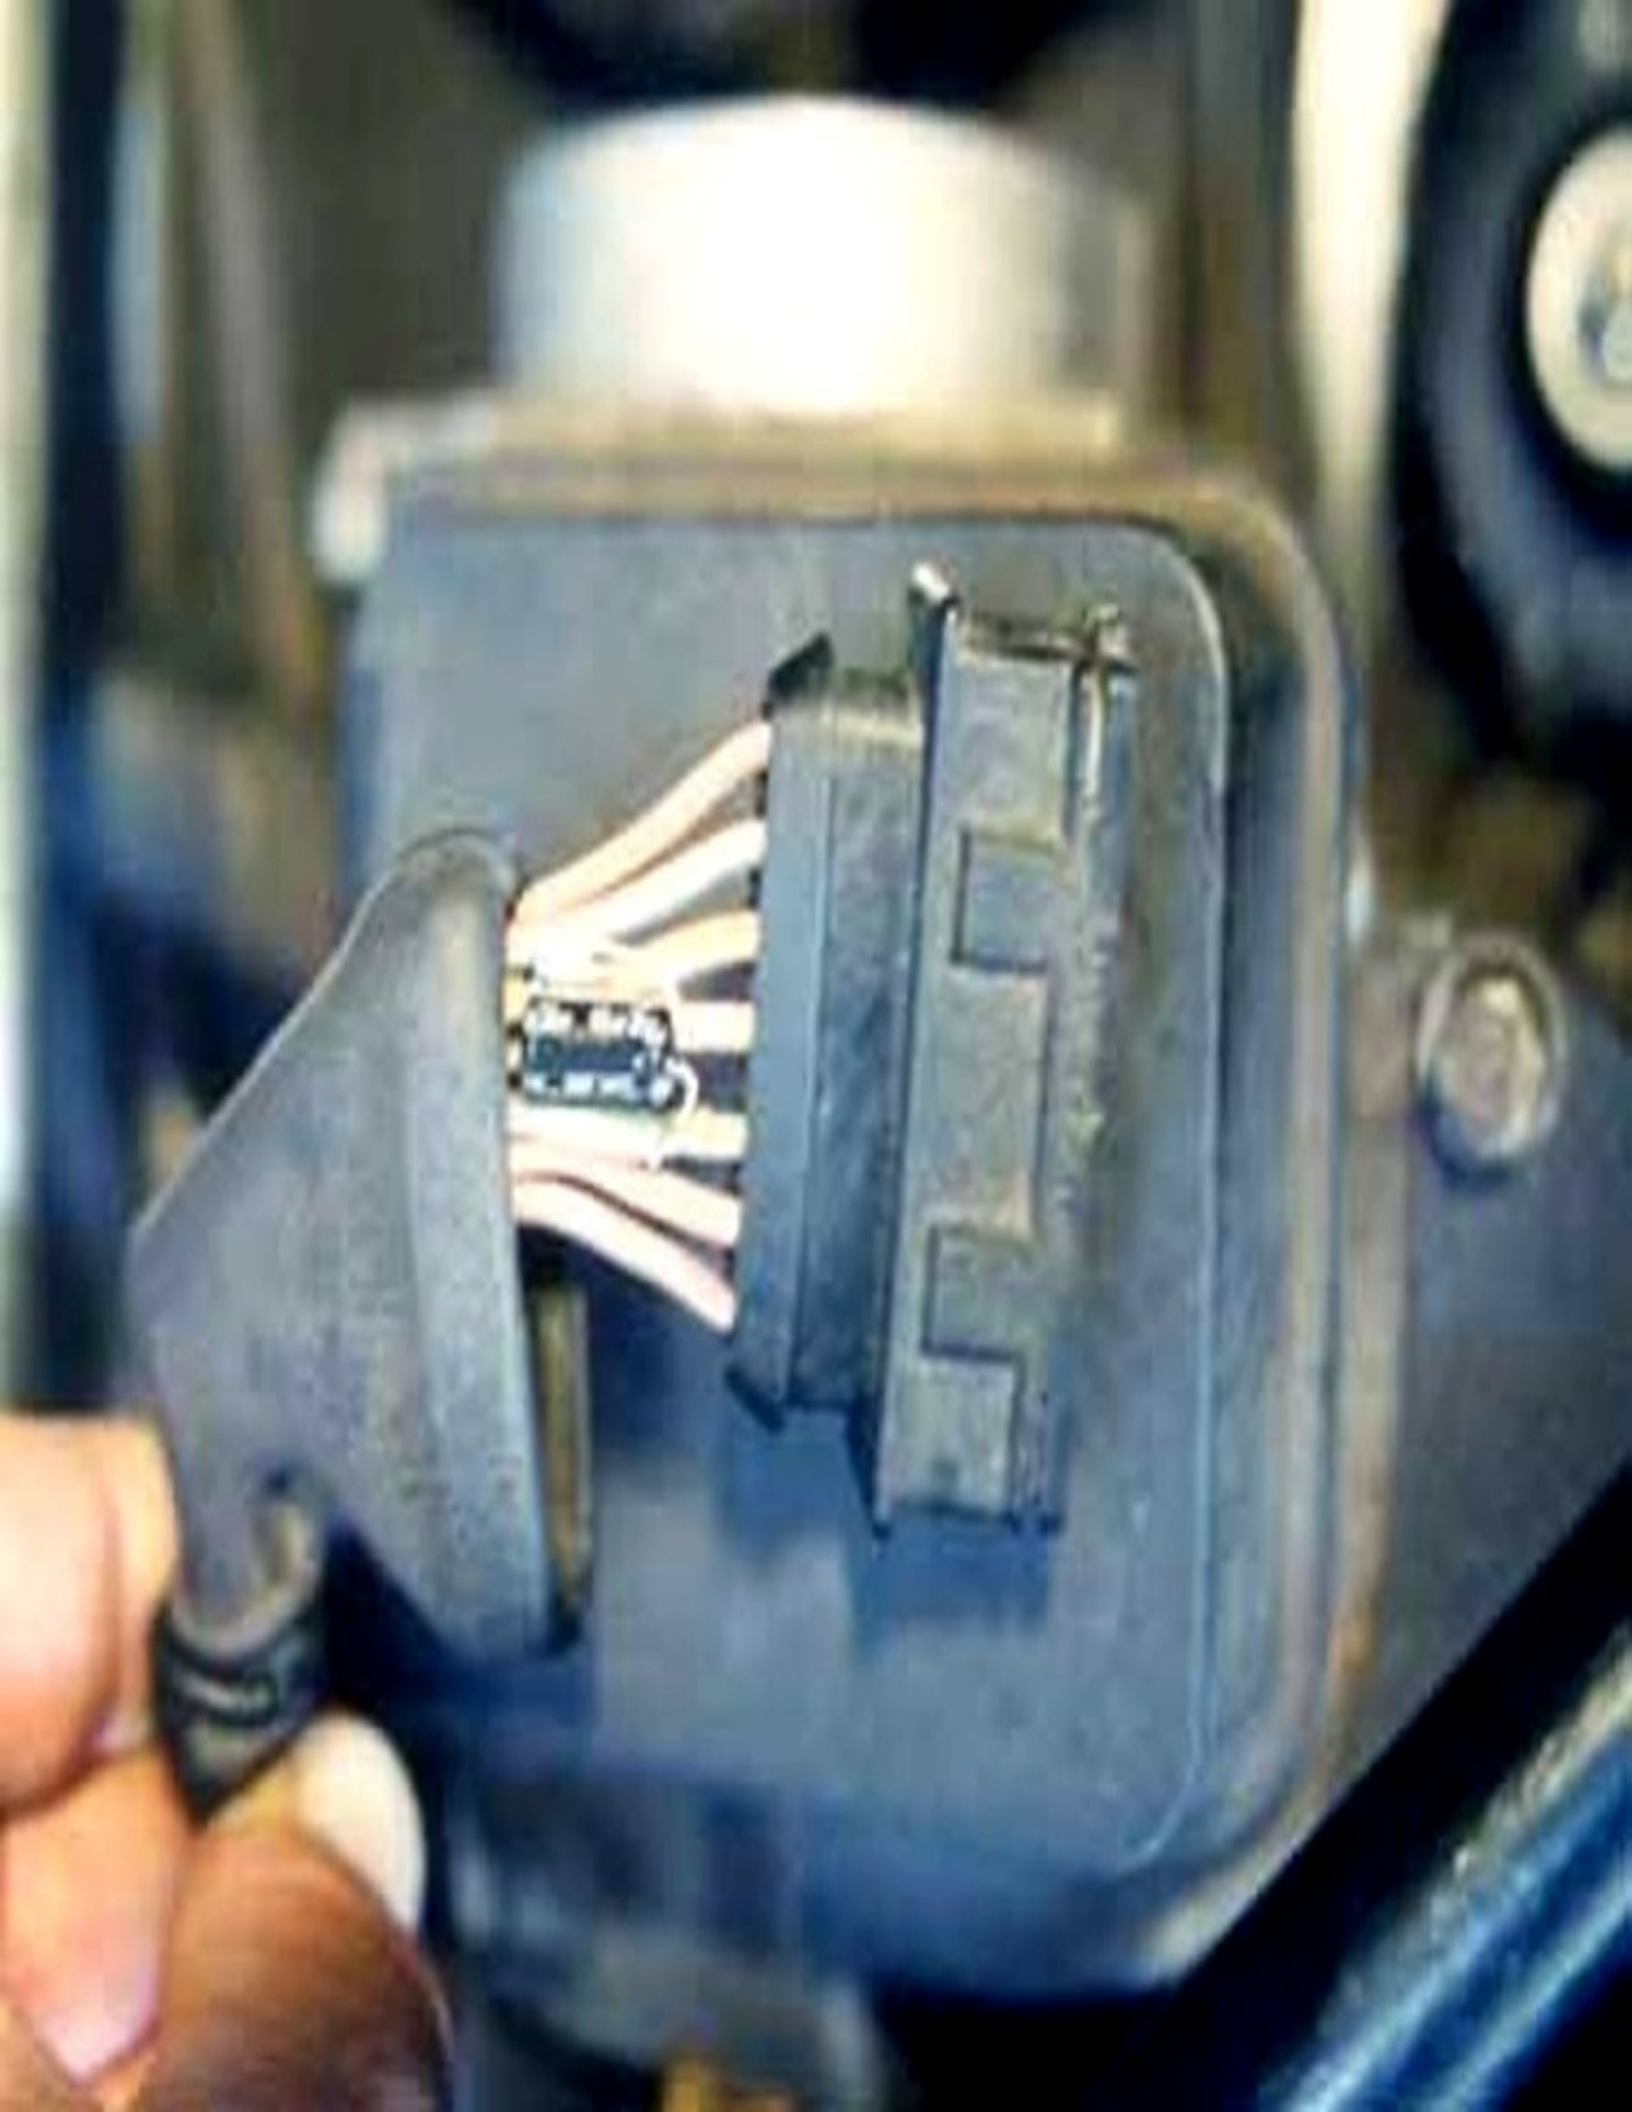
It has been established that the cause of some 4.2 Series III engines misfiring and producing black smoke through the exhaust when the car is accelerated or driven way with the engine in either a cold or part warm state, is due to overfueling.

This is caused by continuous triggering of the acceleration enrichment circuit during the warm up period (Note: There is no acceleration enrichment above 75°C).

The acceleration enrichment circuit can malfunction due to either poor or dirty connections on the airflow meter plug/socket connection.

A 100 Micro Farad, 25 Volt Electrolytic Capacitor should be soldered across terminals 6 and 8 of the Air Flow Meter harness multiplug ensuring that the negative lead of the capacitor is connected to terminal 6 (six) and the positive lead of the capacitor is connected to terminal 8 (eight).

- 5. To enable fitment of the capacitor to terminals 6 and 8, as detailed in Fig 1, it may be necessary with some types of capacitor to lengthen the existing capacitor wires. Wires of a similar gauge should be soldered to the existing wires, if additional length is required.***
- 6. Route the capacitor wires through the harness grommet and solder to terminal 6 negative and 8 positive, ensuring polarity is maintained.***
- 7. Relocate and secure terminals 6 and 8 into the multiplug.***
- 8. Replace rubber grommet and reconnect multiplug to air flow meter.***
- 9. Secure the capacitor to the harness, either using suitable tape or a plastic ratchet strap.***
- 10. Reconnect battery and check vehicle operation from cold start.***

- use 30 to 100 microfarad capacitor**
- band or negative lead towards the front**
- capacitor wires are soldered to the wires on either side of the middle wire**
- spray the soldered connections with clear plastic spray paint to protect from moisture**
