Number	FF.1
Section	Automatic Transmission
Sheet	1 (of 1)
Date	May, 1960

TORQUE CONVERTER SETSCREWS

(All Automatic Transmission Models)

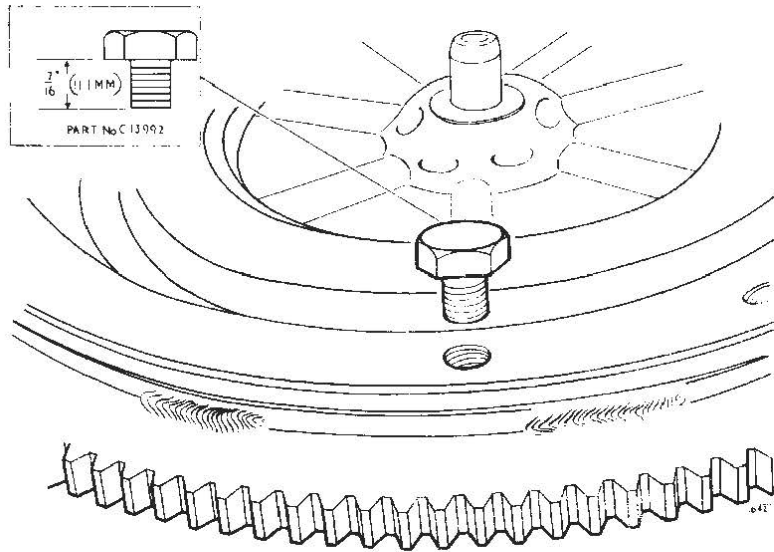
FIG 1

Note that it is ABSOLUTELY ESSENTIAL that the long setscrews which are $17/32"$ (13.5 mm) in length (see inset in Fig.2.) are not fitted to a torque converter which does not have cut-a-ways machined under the setscrew holes, otherwise the setscrews will bottom in the holes. A torque converter without the cut-a-way is illustrated in Fig.1; the $7/16"$ (11.1 mm) long setscrew which MUST be fitted to this type of converter is shown inset.

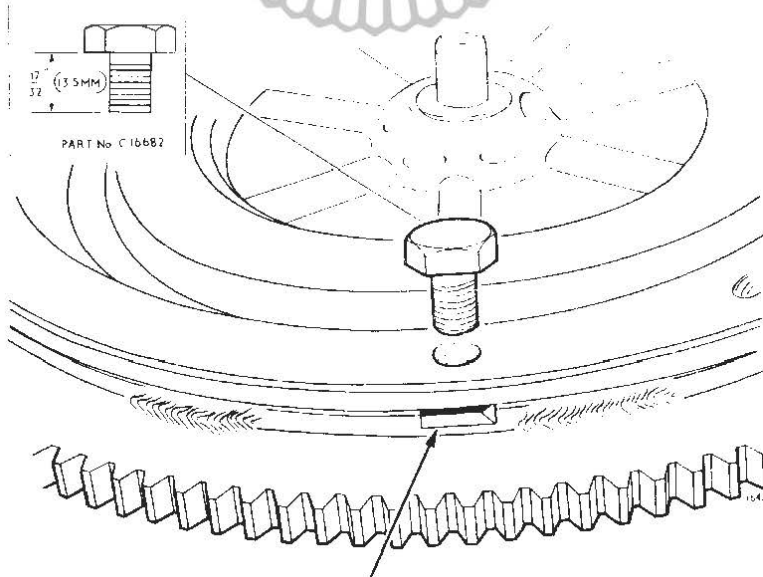
FIG 2

Torque converters are now secured to the drive plate with longer setscrews (Part number C.16682). To ensure full engagement of the longer thread, a cut-a-way is machined in the torque converter below each threaded hole as indicated by the arrow in Fig.2.

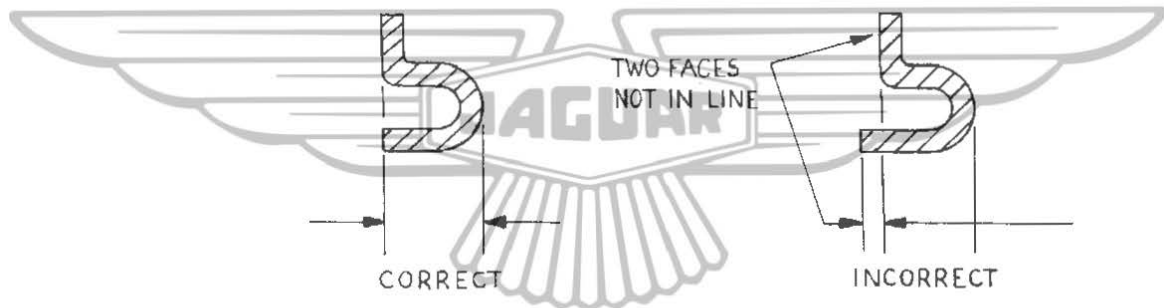
Information has been received from the Manufacturers of the Automatic transmission unit to the effect that some of the above units have been built with a dimensionally faulty rear clutch piston spring seat.

The fault is best described by reference to the sketches below.

The effect of this fault is to reduce the length in which the rear clutch spring has to operate, which, under adverse tolerance conditions of all the rear clutch components, can allow the spring to become solid before the rear clutch is fully engaged.

1. Soft 2 - 3 shift.
2. Breakaway on 5 - 2 shift.
3. Judder or clutch squawk in reverse.

When the rear clutch is stripped, the clutch piston spring seat should be checked and if the two faces are not in line within .020" (.508 mm.) should be discarded and replaced with a part that is correct to drawing.

This may be obtained from JAGUAR SPARES DIVISION, COVENTRY, under Part Number 9806.
