Distortion Measurements in the 'Generic' Region, Western Systems

Significant distortions appear in three of the four systems as documented by the following waveforms and comments

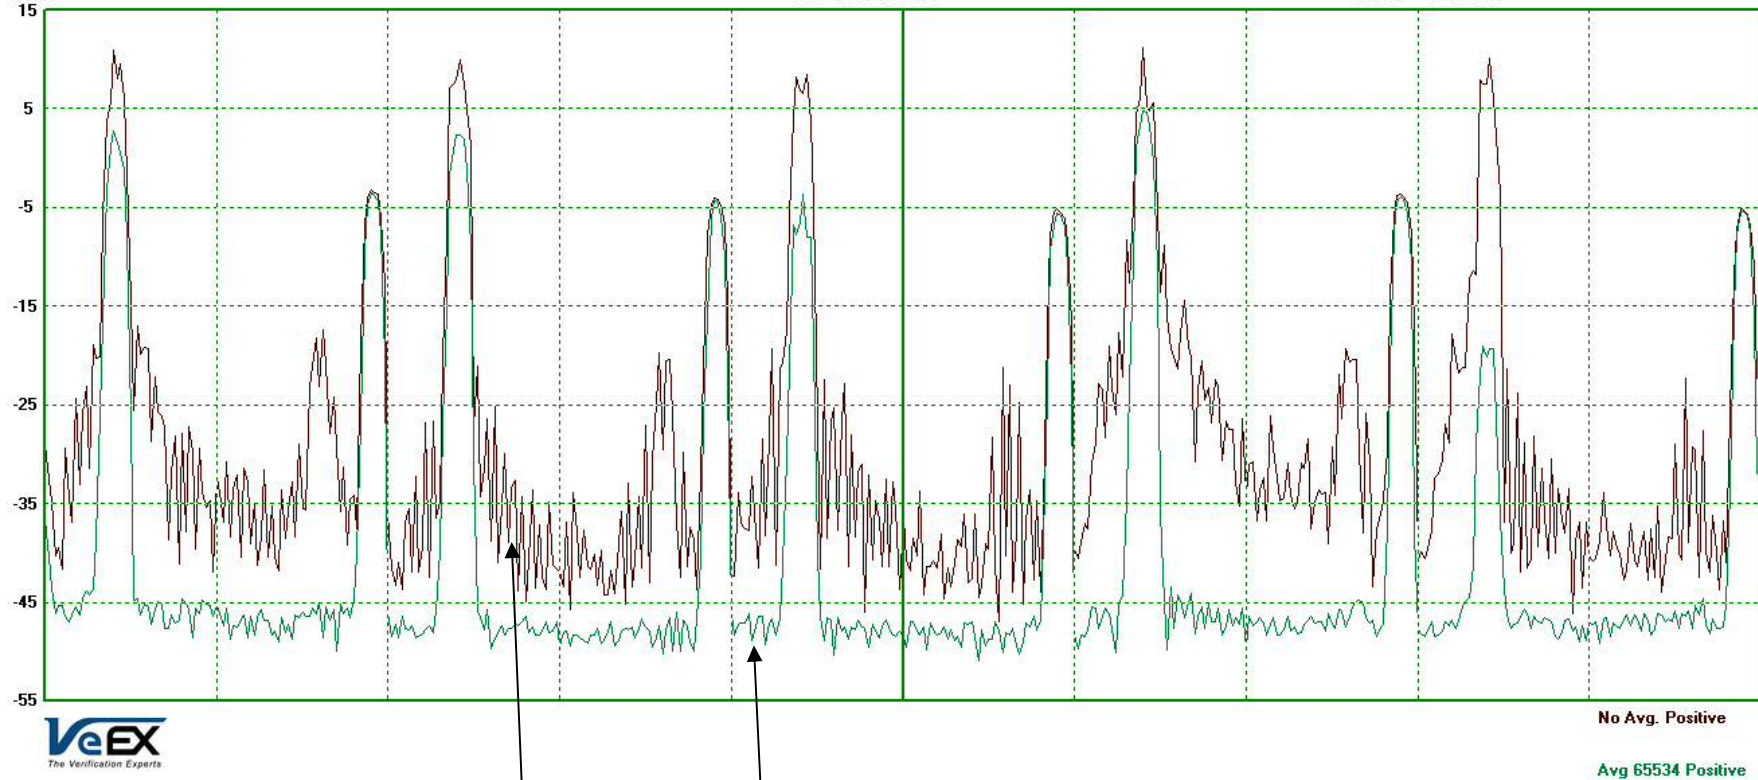
Channels 50 through 54 at the 'System 1', ST System Test Point

Channels 50 through 54 with 'real time' and 'minimum hold' (green) traces activated. Note there are no intermodulation beats present; only the visual and aural carriers remain in 'min-hold', since in an NTSC-M system only those two carriers remain on all the time.

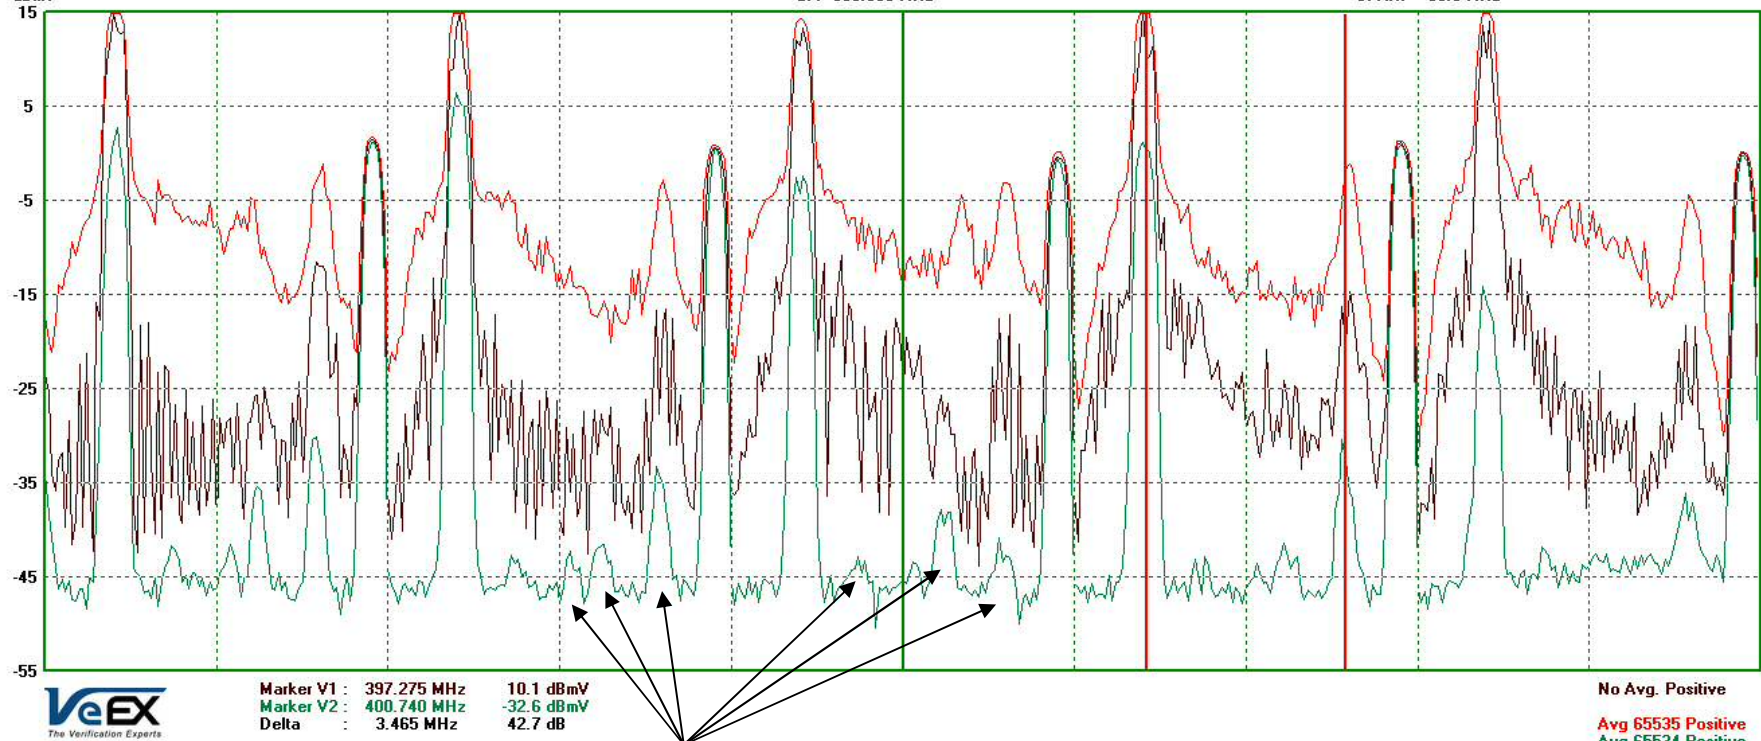
Channels 50 through 54 at the 'System 2', ST System Test Point

Channels 50 through 54 with 'real time', 'peak hold' (red) and 'minimum hold' (green) traces activated. Note there are now many intermodulation beats present in the 'min-hold' trace, and although it's not readily apparent, all of them are mathematically related by the following relationship: $[Luminance\ carrier \pm \sim 3.5\ MHz]$, & $[Aural\ carrier \pm \sim 3.5\ MHz]$. Given that relationship, this is not classic CSO or CTB.

1. At the headend, all four systems are fed from the same 'post amplifier'. After the post-amp, the 'System 1' system (the closest geographically) is fed via a separate laser, with the remaining three systems ('System 2', 'System 3' & System 4) fed via a launch laser (laser transmitter) and EDFA. The 'System 1' system is free from these intermodulation products, whereas the three systems fed via the laser transmitter and EDFA have the distortions present. A second EDFA and 3-way coupler are located approx. 40 km away and the problem could also be at this location. This is not classic CSO or CTB, as the required mathematical relationship between the carriers and beats is not present. Rather, all beats appear to be related by the following: [luminance carrier \pm ~3.5 MHz] & [aural carrier \pm ~3.5 MHz].

2. I believe the most likely causes are:
 - Pre-distortion problems in the 'launch laser'. Laser transmitters generally pre-distort the RF response to minimize the effects of SBS.

- Dirty or pitted optical connector somewhere between (and including) the launch laser output and 1st EDFA output.
 - 1st EDFA.
 - Dirty or pitted optical connector between the 2nd EDFA output & optical coupler input at the 'System 2' location.

- 2nd EDFA
3. SBS is not thought to be a factor, nor are the optical connectors at the 2nd location (2nd EDFA, 3-way coupler, or connecting jumper) – although it's not totally out of the question. I've therefore included that as the last options to check in #2 above.

4. The 'launch laser' will be changed first, and if that's not the problem the system will move on to the other possible areas noted in #2 above. Although the system does not have access to a spectrum analyzer with a minimum-hold trace, they should be able to determine if the problem is resolved by monitoring C/N on a low frequency channel at any of the three effected field test points. CCN on CH04 measured at approx. 35 dB (very poor), and I anticipate it will improve by approx. 10 dB when this problem is resolved. Also, confirm the optical input power to the 2nd EDFA if possible. It should be +6 dBm minimum at 1510 nm.

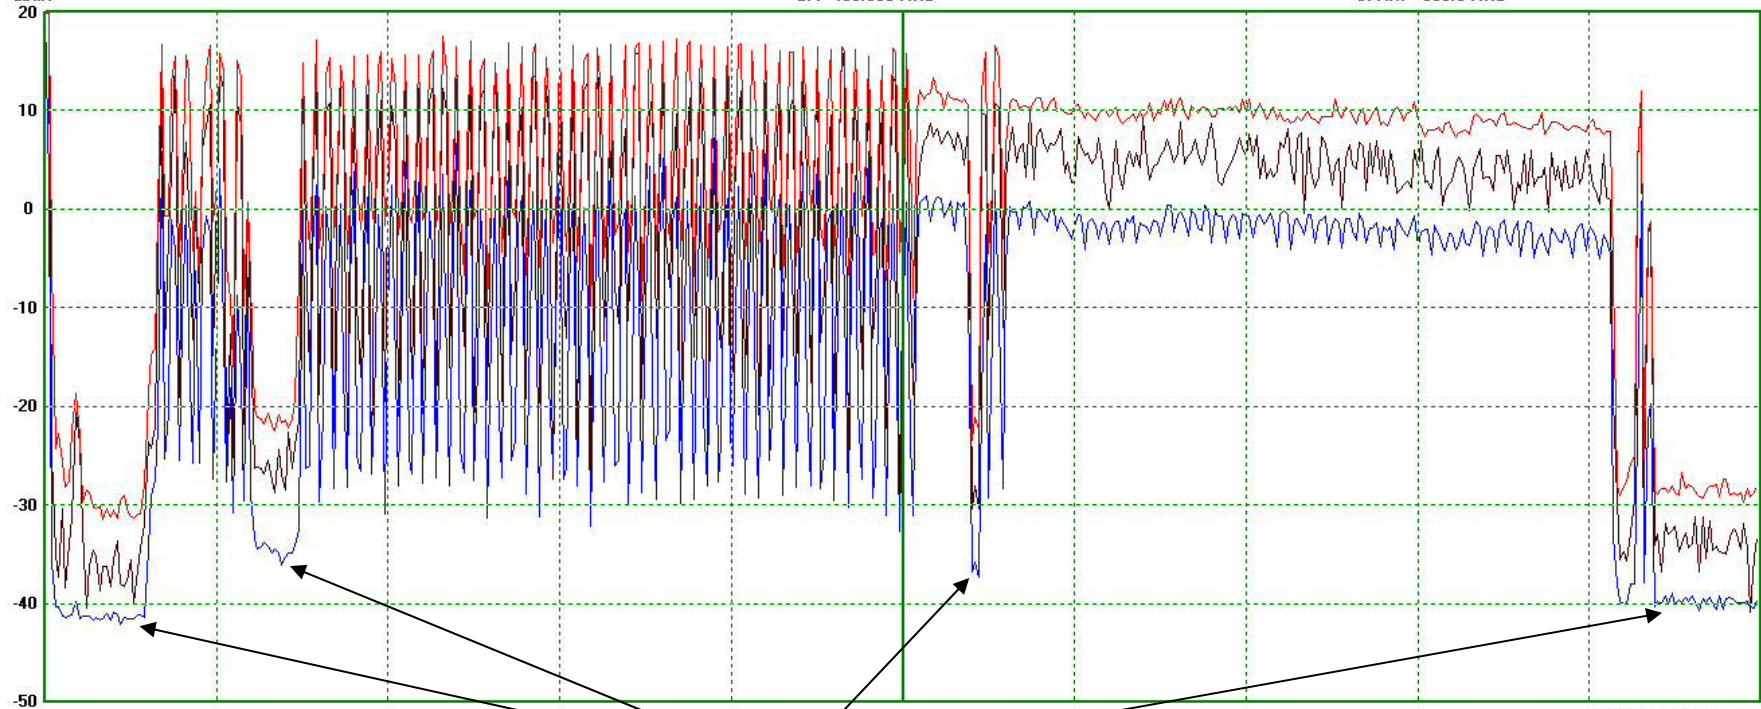
Overall Response at the 'System 2', ST System Test Point

This overall system response waveform includes an 'average trace' (blue, 10 samples) that better illustrates the 'raised noise floor' that is present in the three effected systems.

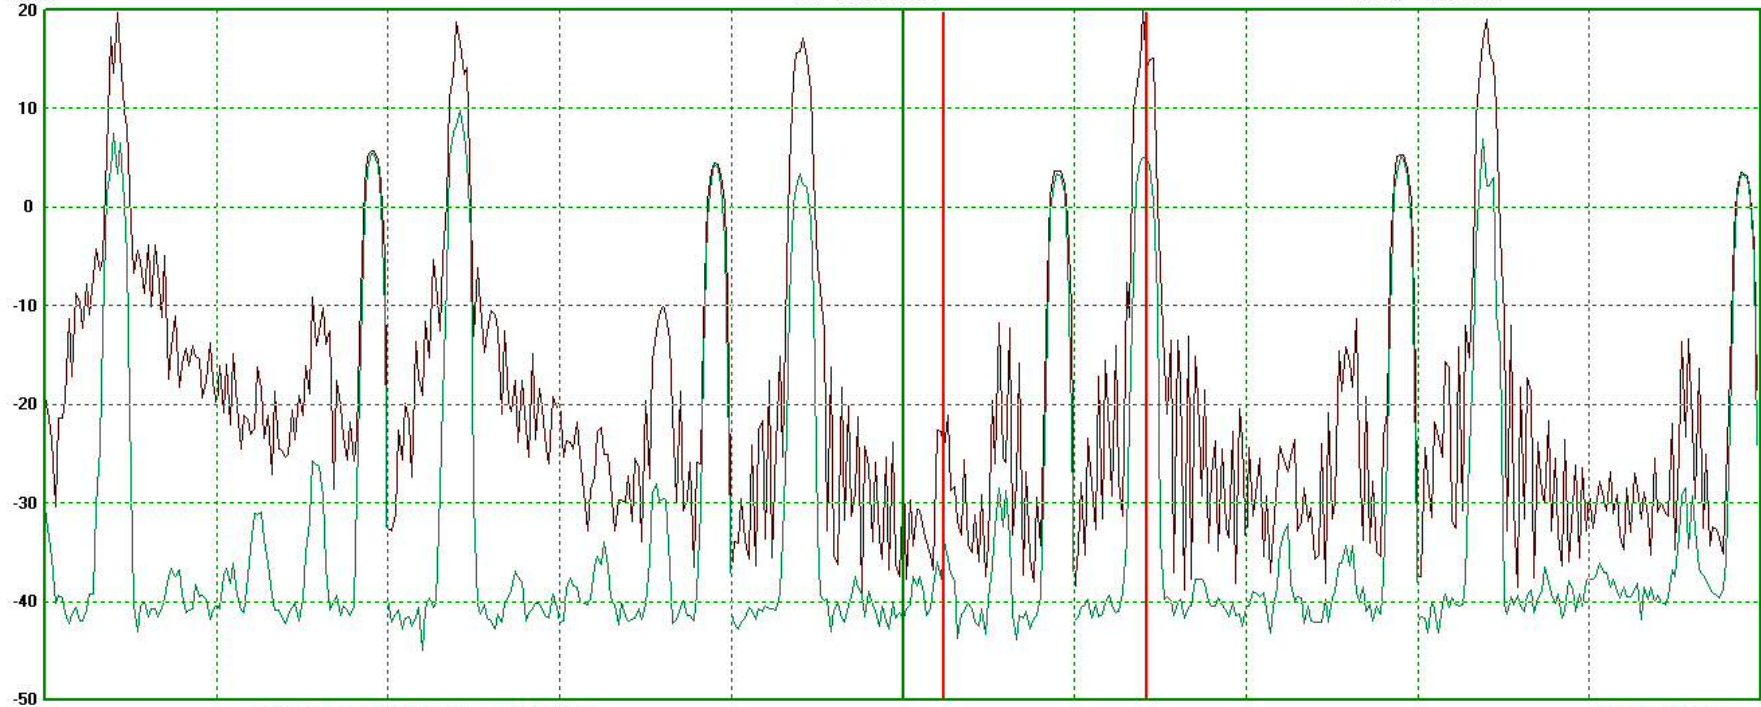
Channels 50 through 54 at the 'System 3', ST System Test Point

Channels 50 through 54 with 'real time' and 'minimum hold' (green) traces activated. Distortions remain the same.

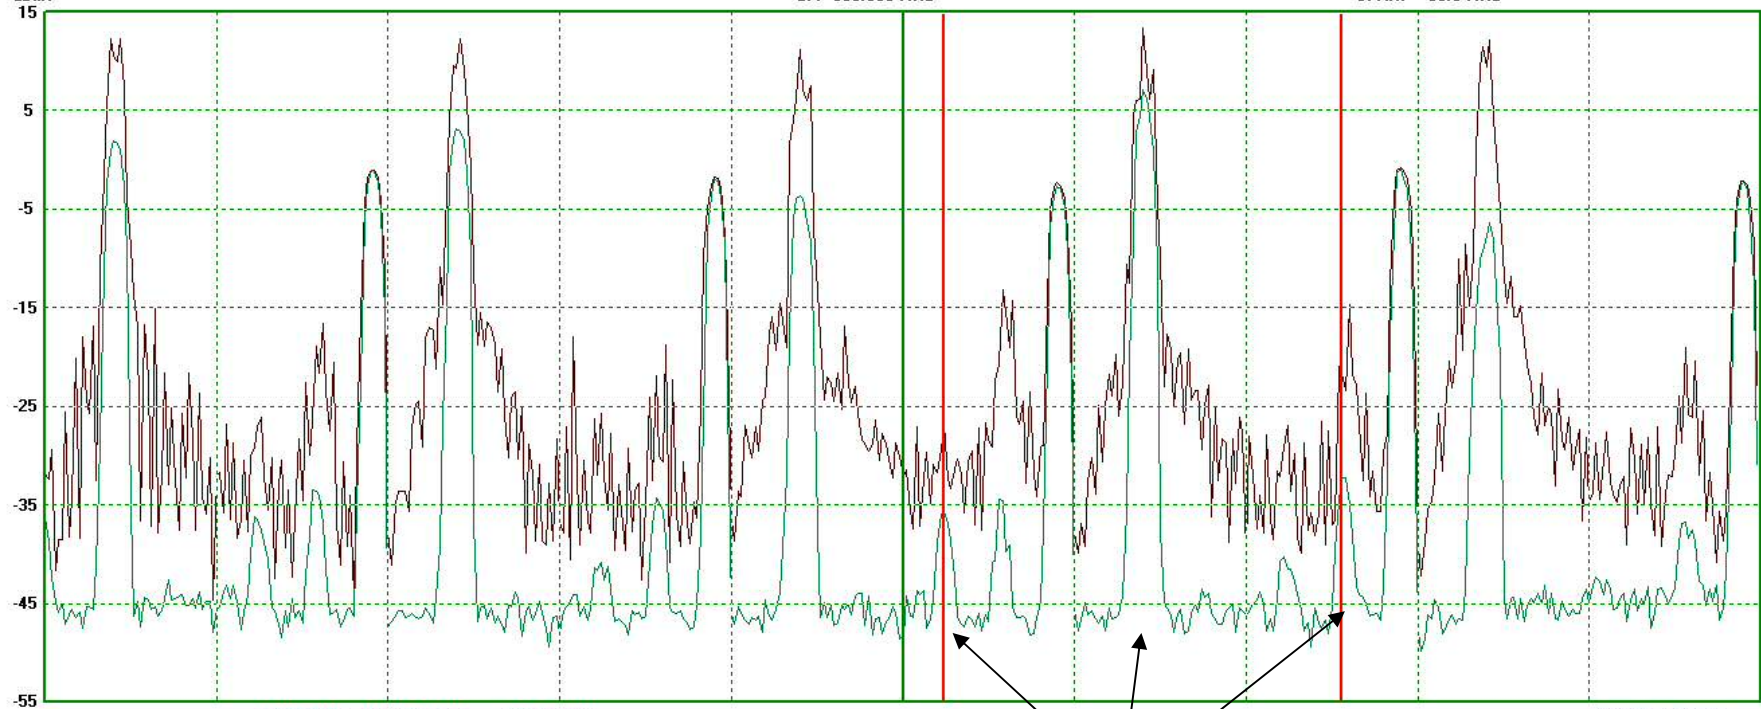
Channels 50 through 54 at the System 4, ST System Test Point

The markers above are positioned to illustrate {the} two beats that are $\pm \sim 3.5$ MHz from the CH53 luminance carrier.
Channels 50 through 54 with 'real time' and 'minimum hold' (green) traces activated.
