Florida Building Inspection Group PO Box 1633 Riverview, FL 33568

SUMMARY ROOFING EXTERIOR STRUCTURE ELECTRICAL HEATING COOLING INSULATION PLUMBING INTERIOR

SUMMARY Report No. 21885

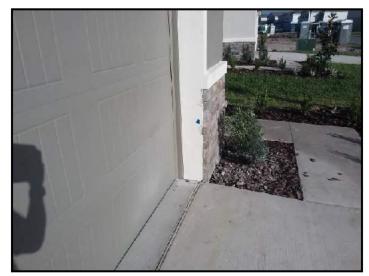
1. Paint touchups

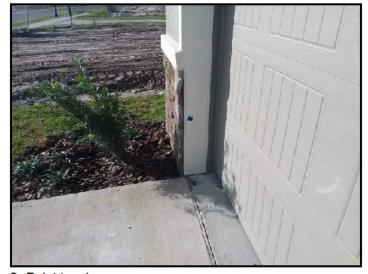
2. Paint touchups

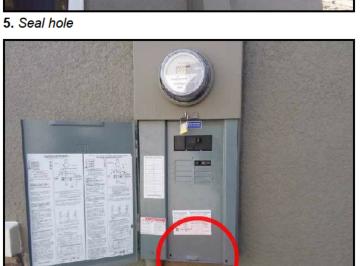
7. Missing fasteners

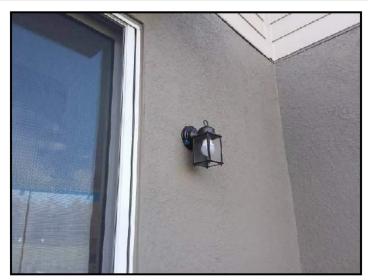
6. Caulking needed

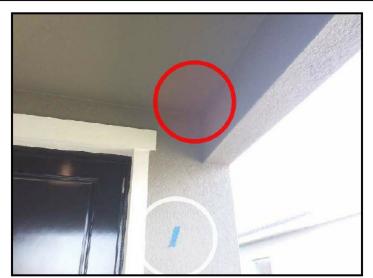
9. Exposed drywall screws

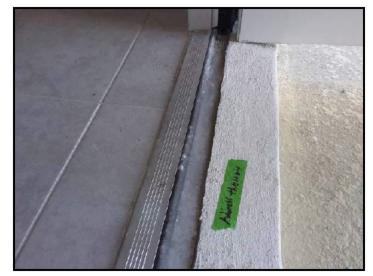
12. Adjustment needed to stucco at threshold

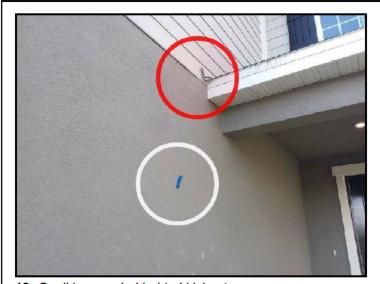
13. Caulking needed behind kickout

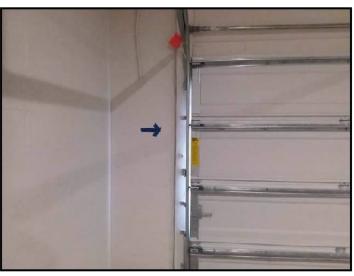
14. Light noted around garage door

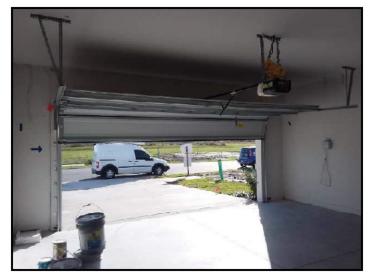
15. Adjustment needed to garage door

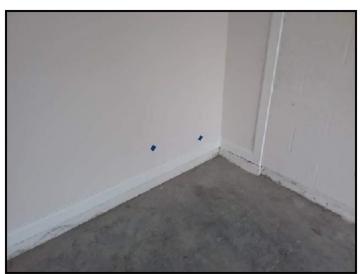
18. Minor damage to drywall

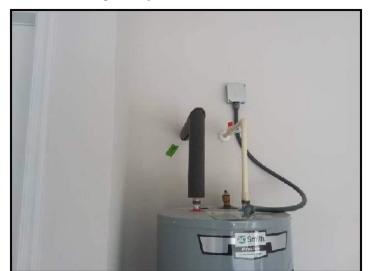
19. Paint touchups

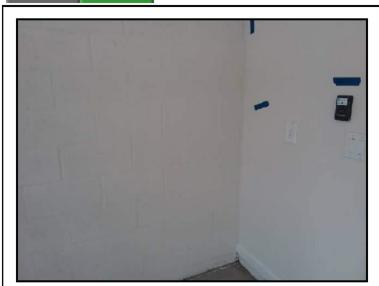
21. Paint drips

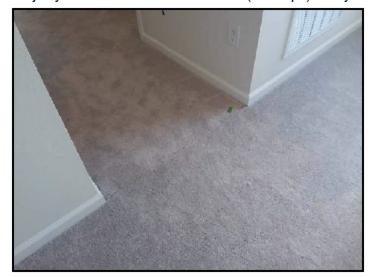
26. Seam in carpet

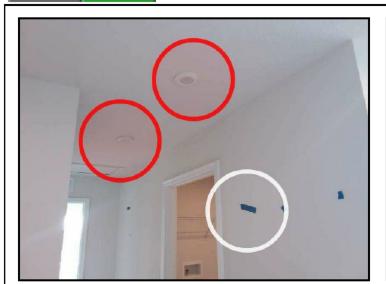
28. Inoperative lights

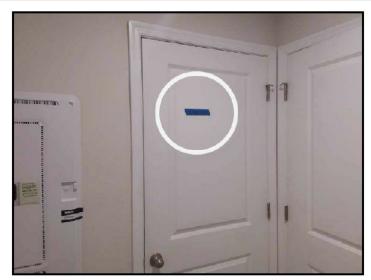
32. Sealant needed around plenum on inside

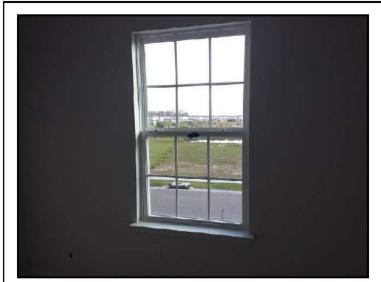
40. Stiff/adjustment needed

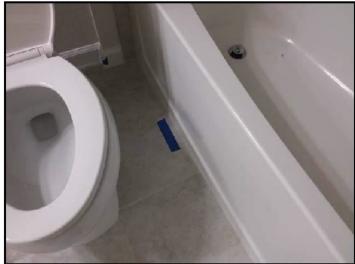
45. Grout cracking

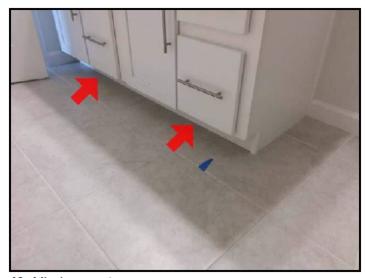
46. Missing grout

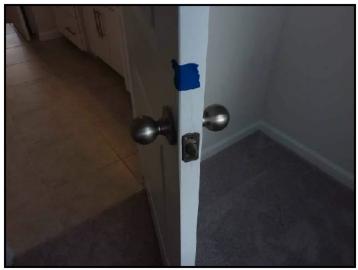
50. Cracked door

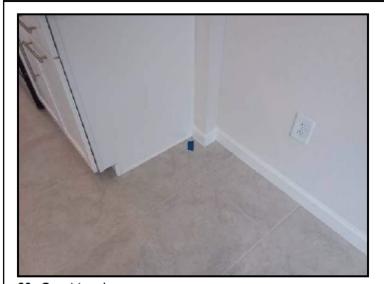
60. Grout touchups

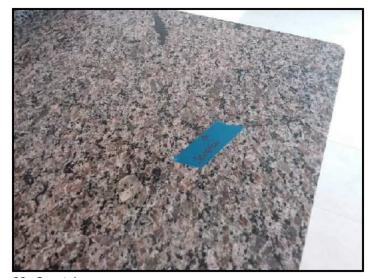
63. Scratch

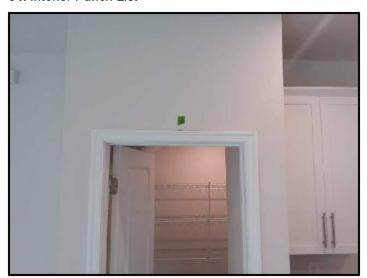
65. Minor damage

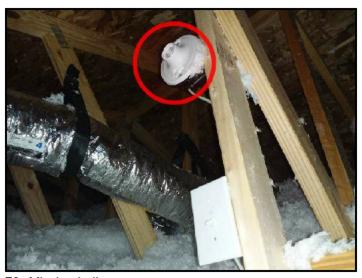
70. Missing bulb

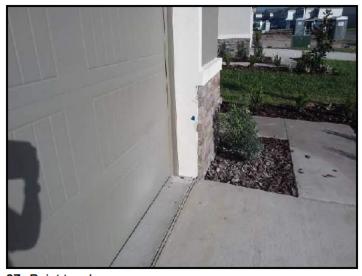
87. Paint touchups

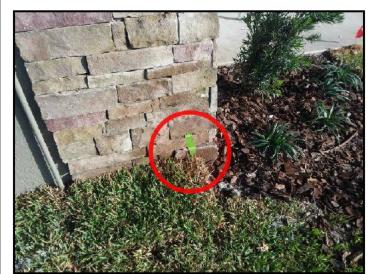
89. Loose stone work

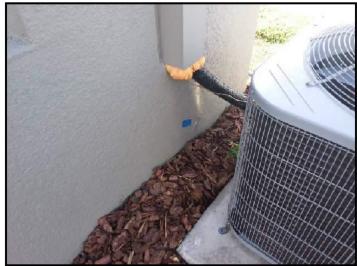
90. Paint touchups

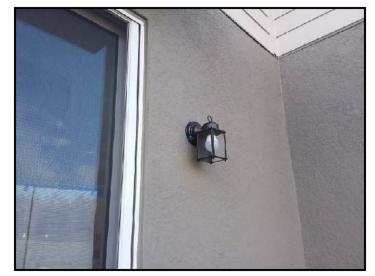
92. Caulking needed

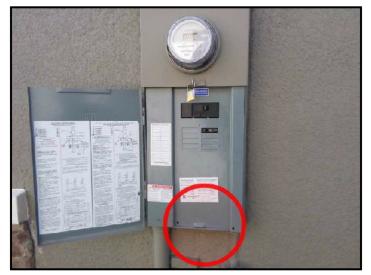
93. Missing fasteners

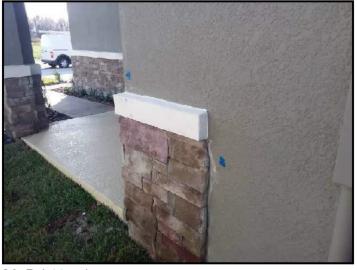
94. Paint touchups

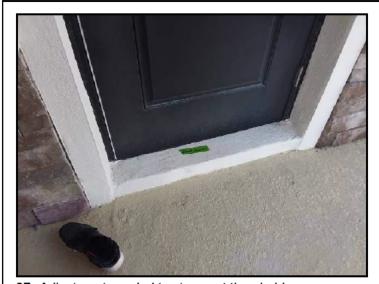
97. Adjustment needed to stucco at threshold

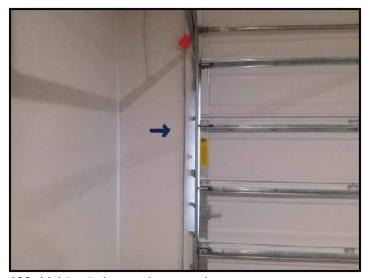
100. Light noted around garage door

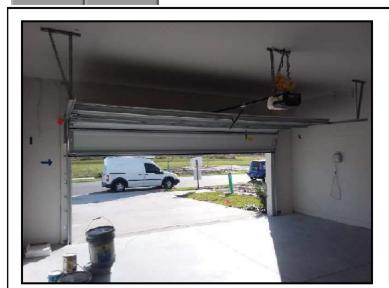
101. Adjustment needed to garage door

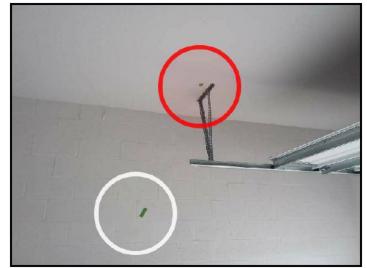
104. Minor damage to drywall

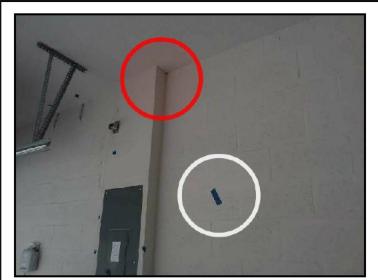
109. Sealant needed

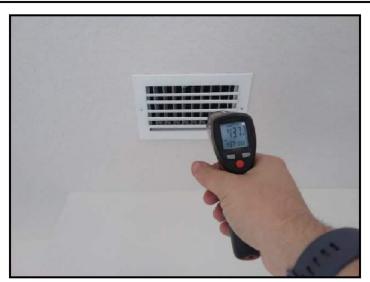
120. 43°

Temperature difference across cooling coil: • 15° • Acceptable temperature difference: 14° to 22° • This suggests good performance.

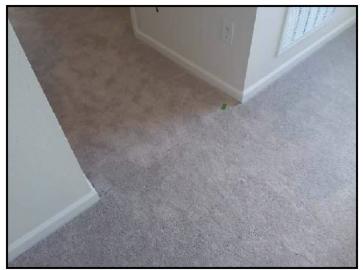
142. Seam in carpet

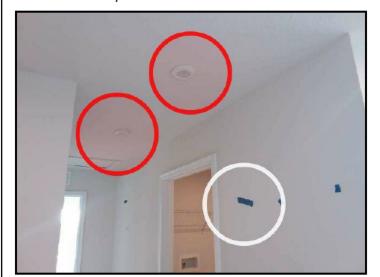
144. Inoperative lights

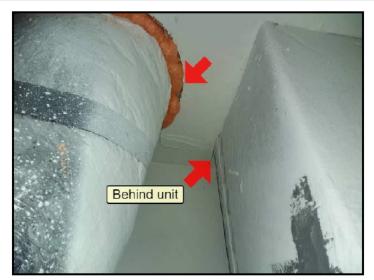
150. Sealant needed around plenum on inside

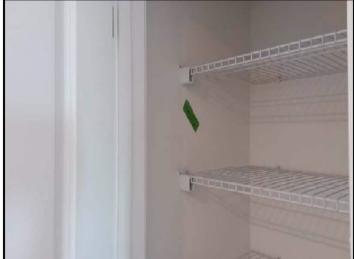
166. Cracked door

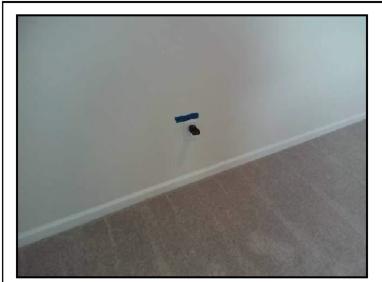
170. No power to outlet

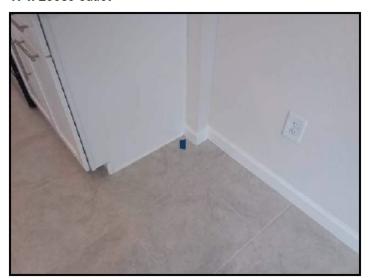
175. Grout touchups

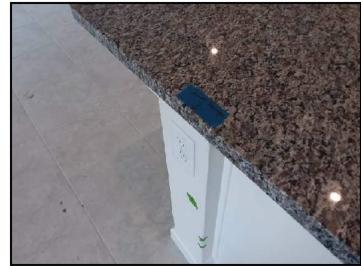
181. Minor damage

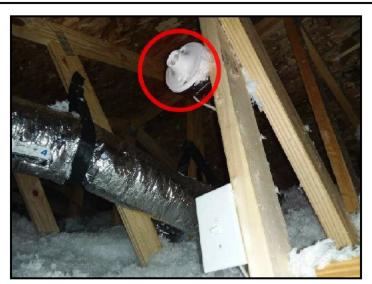
186. Missing bulb
