Description of Property:

N.Y.S. Licensed Home Inspector

SAMPLE REPORT

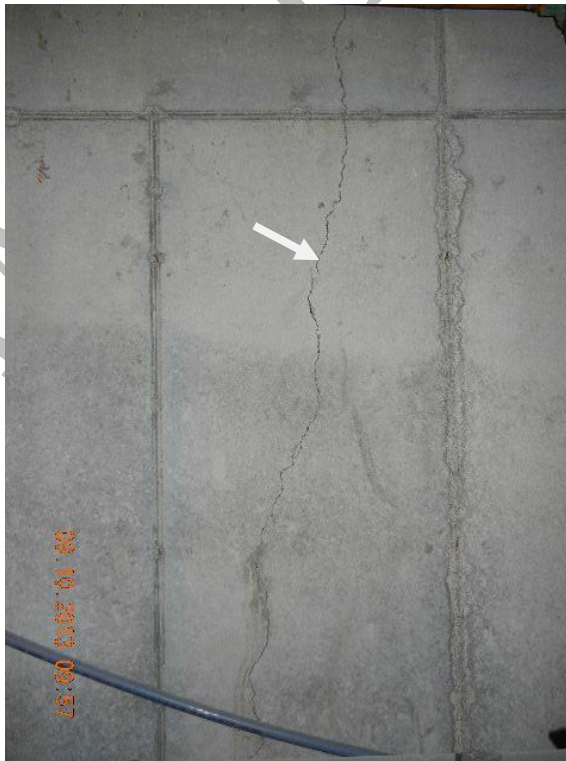
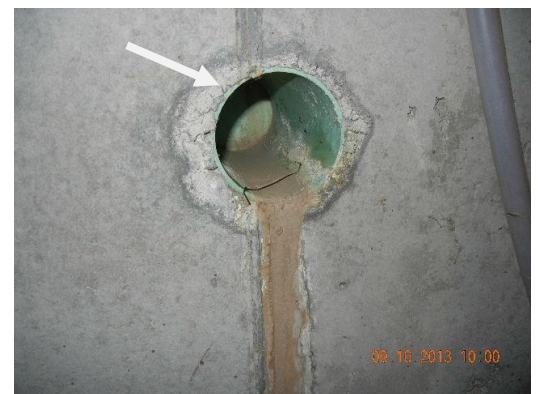
a poured concrete foundation 12 inches thick is installed and was visible in the interior utility room only. A vertical crack was observed the height of the wall which should be sealed with epoxy cement. See photo below. An unused utility opening in the wall should be sealed. See photo below. Otherwise in good condition where visible. *If additional movement occurs structural repairs may be required.* Below the fireplace concrete blocks are installed.

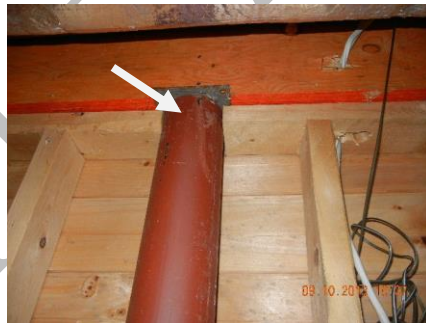
- *Girder (5) – a 4" x 12" laminated wood girder is installed. Condition good where visible.
- *Posts (6) – two fixed metal posts are installed. The top of the posts need to be secured to the wood girder. See photo below. I was in good condition.

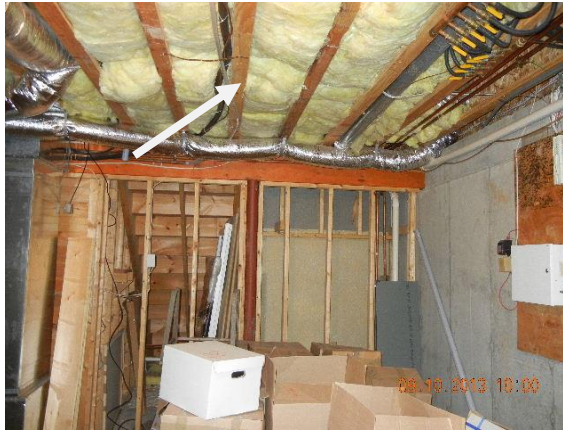
- Interior Stairs – a solid wood frame staircase is installed. Condition good.
- Windows (7) – no windows are installed in the utility room.
- Ventilation – *there is no direct ventilation installed to the exterior except by an exhaust fan. It was not possible to locate the controls to operate the fan and it is recommended that the present owners be contacted.*
- *Insulation – approximately 6 inches of fiberglass insulation is installed in the entire utility room ceiling. *It is recommended that a ceiling finish be installed to prevent airborne fiberglass particles.* See photo below.

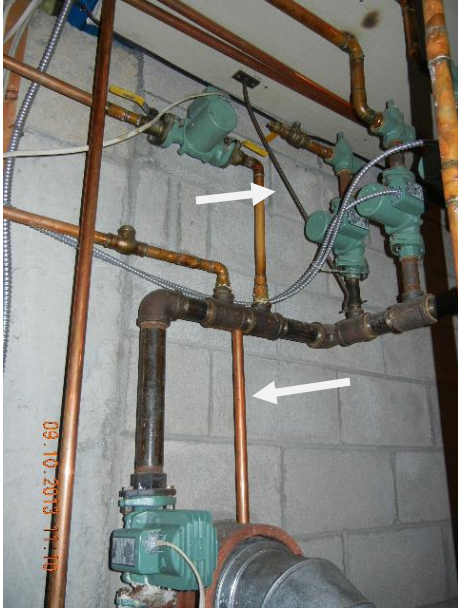
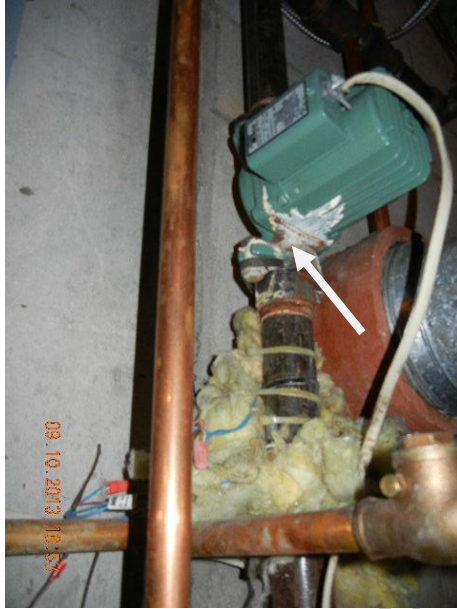
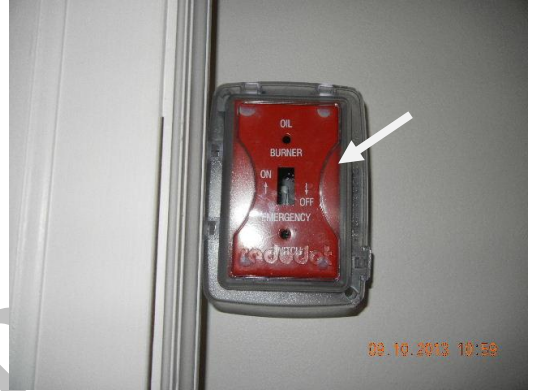
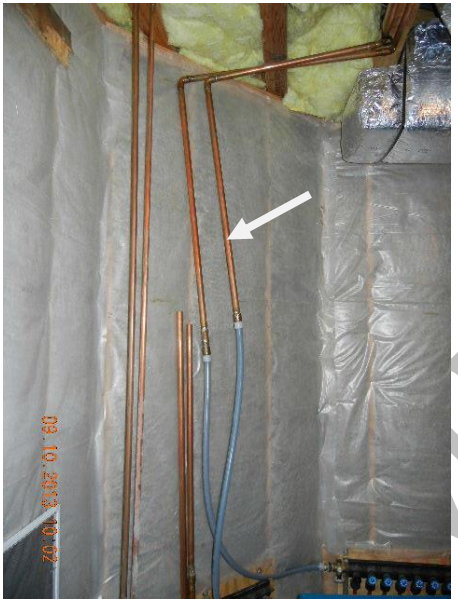
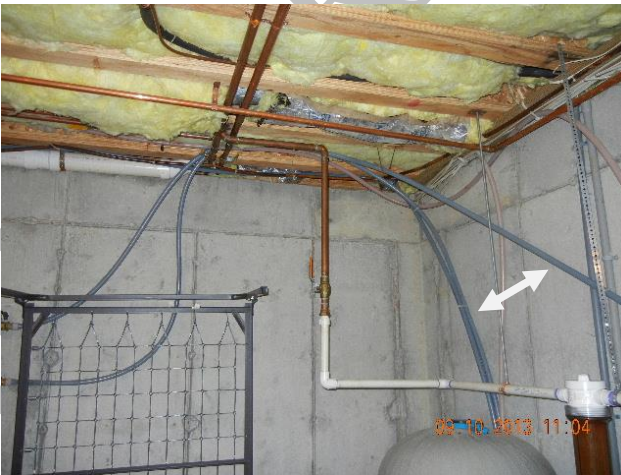
Type of Heating System – a Smith brand oil fired hot water boiler is installed in the basement and is rated at 169,000 BTU. Radiant heat is installed in conjunction with a water to air heat exchanger which also produces hot air. Both systems run concurrently. A total of 14 circulators are installed. *Corrosion was observed at the joint of the main circulator installed directly above the rear section of the boiler and repairs are required an additional support for the manifold is required. See photos below. Additionally the radiant pipes installed in the utility room floor had been disconnected and appear to be connected to the radiant heat installed in the finished section of the lower-level. Additional support needs to be installed. See photo below. When operated this section and the system installed in the garage did not produce significant heat increase and servicing or repairs are required. Additionally the supply and return lines for the garage radiant heat at the left side utility room wall also need to be supported. See photo below. It is recommended that the supply and return lines from the boiler to the exchanger be insulated as well as the pipes from the domestic hot water storage tank. The emergency switch for the boiler is installed at the top of the staircase. The plastic box installed over the switch to prevent accidental shutoff is difficult to open as it is not clear the wood trim and repairs are required. See photo below. Otherwise in working condition.*

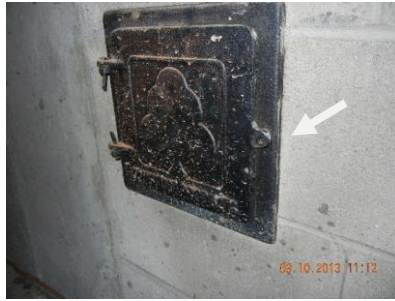
Chimney for Heating System – the interior flue liner was not visible for inspection purposes. *It is recommended that a chimney sweep clean, inspect and evaluate the condition of the chimney.* A metal flue pipe is connected to a masonry chimney. *The clean out door needs to be sealed correctly.* See photo below. Otherwise in working condition.

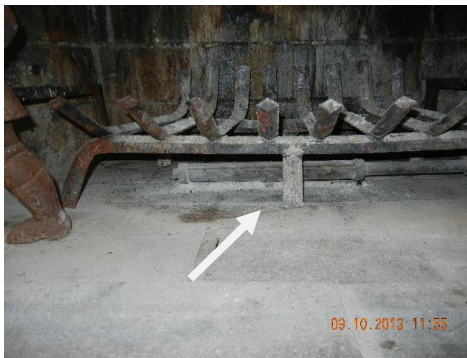
Fireplace (Den) - a site built masonry fireplace is installed in the den. An LP gas manifold is installed below the wood log set perhaps for igniting the wood initially. See photo below. *There does not appear to be a safety mechanism such as a thermocouple mechanism installed to prevent the flow of gas if it is not being ignited and its use isn't recommended for safety purposes.* A metal damper and open screen is installed. Condition not in use at the time of the inspection. Otherwise it has a working appearance.

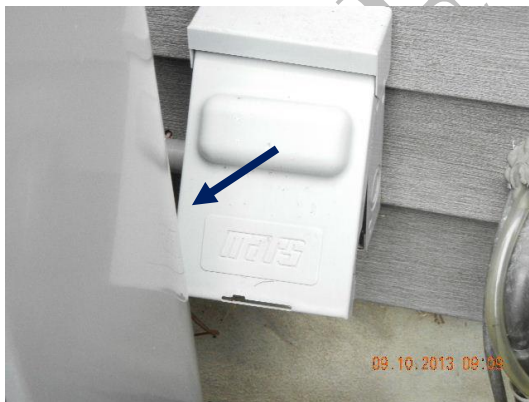
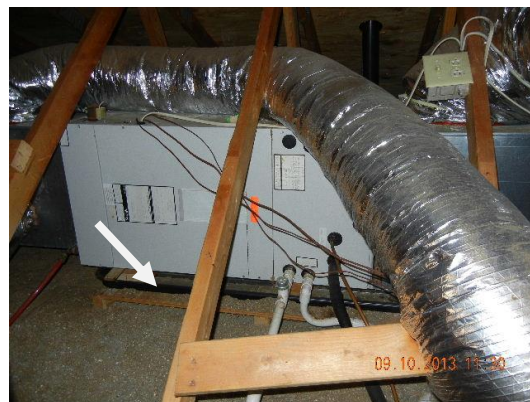
a central air-conditioning system with two compressors are installed at the exterior left side of the home and an air handler is installed in the attic. The left side main electrical disconnect switch could not be operated due to its location as the door interferes with the compressor and needs to be relocated. See photo below. Air-conditioning is provided to the first and second floors and not in the lower-level area or sunroom. The air handler installed in the attic was not accessible due to the fact that no floorboards are installed. Although it is in working condition it could not be fully evaluated. See photo below.

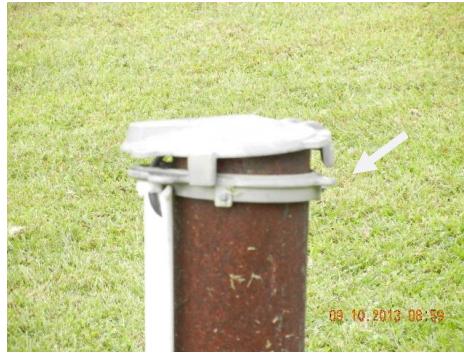
A drilled well with metal casing is installed in the front right side yard. The top metal cap and electrical conduit at the top of the well casing need to be repaired. See photo below. A flow rate of 3 gallons per minute was run for a total of 60 minutes and produced 180 gallons of water with no decrease in the flow of water observed. The amount of water that a water system produces can vary greatly depending on the season.

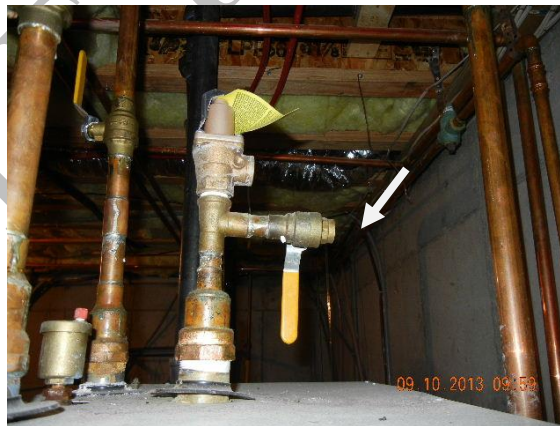
Hot Water Heater (10) – a 119 gallon triangle brand hot-water storage tank is connected to the boiler. A ¾ inch copper pipe needs to be installed on the pressure relief valve. See photo below. Condition working.

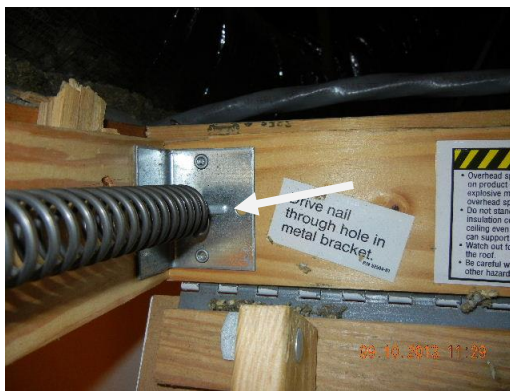
Access to Attic – a pull down staircase is installed. Recommend insulating the staircase. Additionally more fastening screws need to be installed where the pull down staircase frame attaches to the attic floor joists system. See photo below. Otherwise in working condition. *Due to the fact that no floorboards are installed the attic was evaluated visually from the top of the staircase only. The comments listed below are not to be considered conclusive. See photo below.*

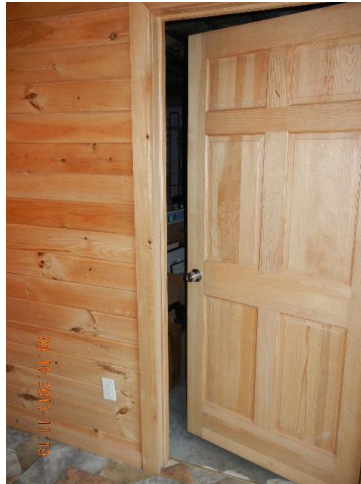
- Kitchen Cabinets - not applicable. A bar is installed with a stainless steel sink which is in working condition. Condition good.
- Additional comments: a grade level wood frame thermopane glass atrium door is installed and provides access to the rear deck. *Additionally*

the entry door into the utility room needs to be repaired as the trim is loose and the door does not close properly. See photo below.

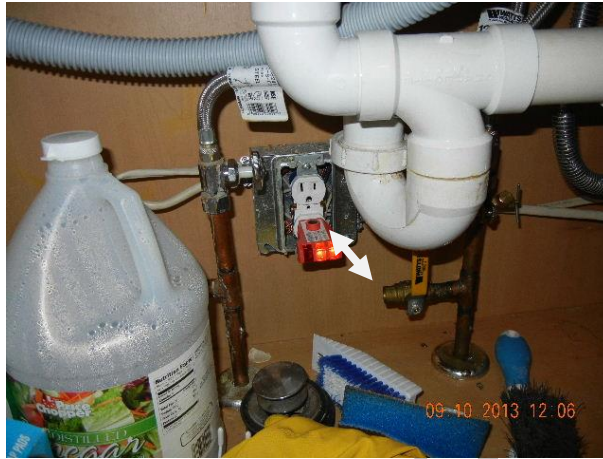
Kitchen Cabinets - wood base and wall mounted cabinets with a granite countertop are installed. The electrical outlet installed in the sink base cabinet should be changed to a GFCI outlet with a wall plate installed and the auxiliary cold water line shutoff valve should have a cap Installed. See photo below. Otherwise in good condition.

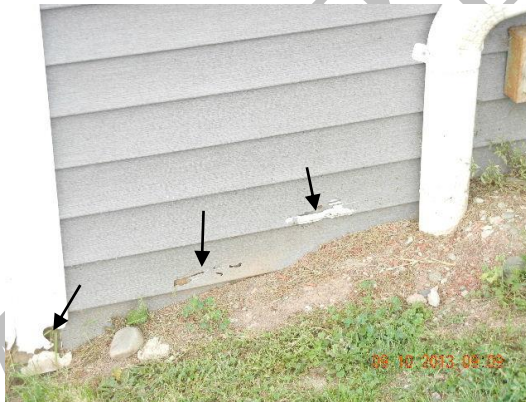
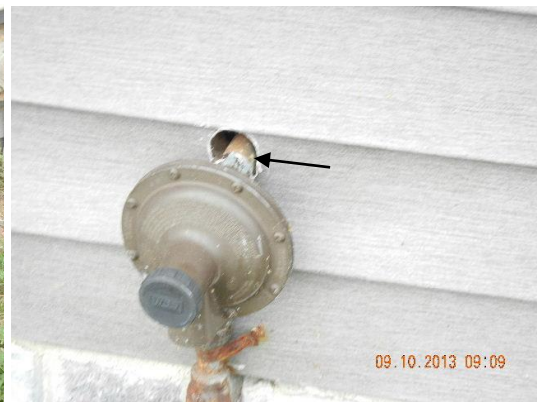
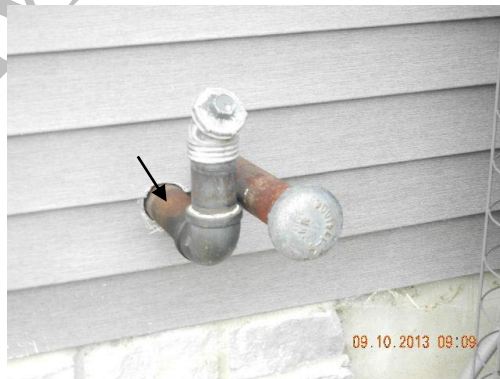
lap board siding is installed. *Minor repairs are required to the lower left rear corner. See photo below. Also where the LP gas line and oil fill and vent pipes are installed the siding needs to be sealed. See photo. Otherwise in good condition.*

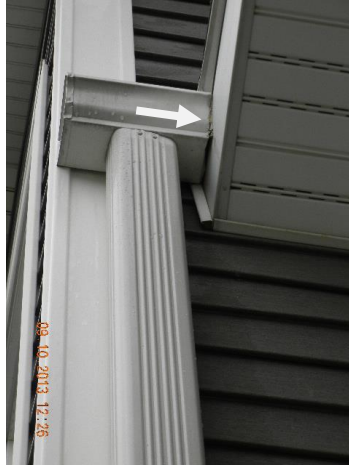
aluminum seamless gutters and leaders are installed. The small section of gutter installed at the left side of the main entryway where it attaches to the fascia is leaking and needs to be repaired. See photo below. Otherwise in good condition. Condition good.

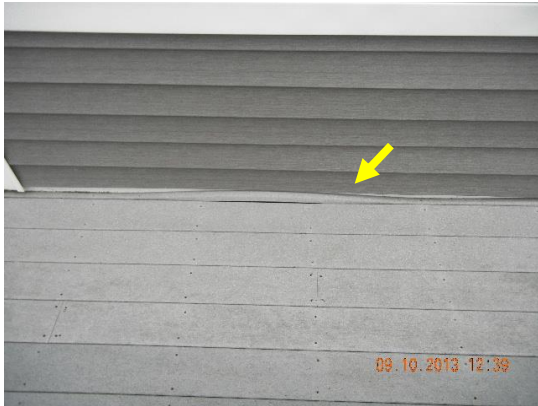
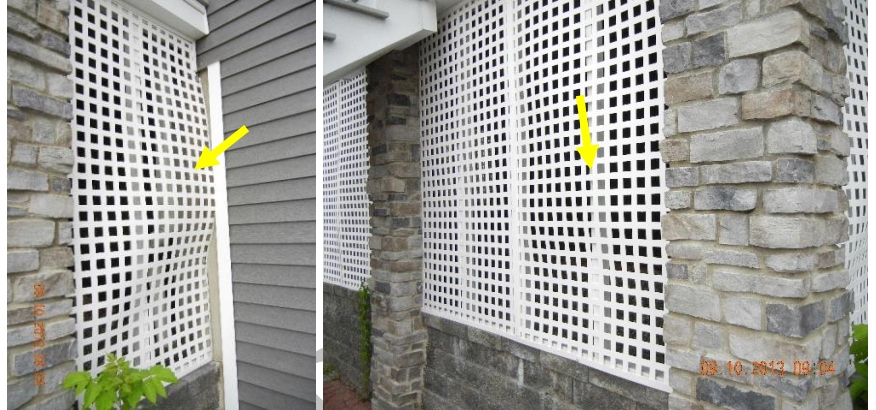
with latticework. Composite decking, handrails and guardrails are installed. A narrow section of decking along the front wall has lifted and needs to be repaired. See photo below. The latticework installed on the rear section of the deck needs to be repaired in spot locations. See photo below. Otherwise in good condition.

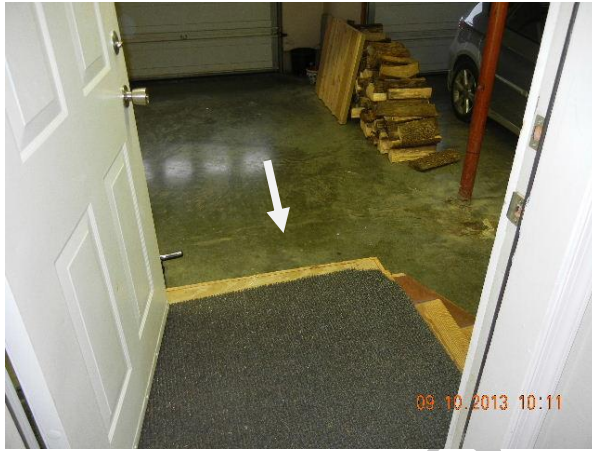
a 3 car attached garage is installed. Two overhead garage doors are installed with automatic openers. A metal insulated entry door is installed on the left side wall. A metal door provides access from the home to the garage and it is required that it be a self-closing door for safety purposes. A guardrail should be installed on the staircase and landing. See photo below. Otherwise in good condition.
