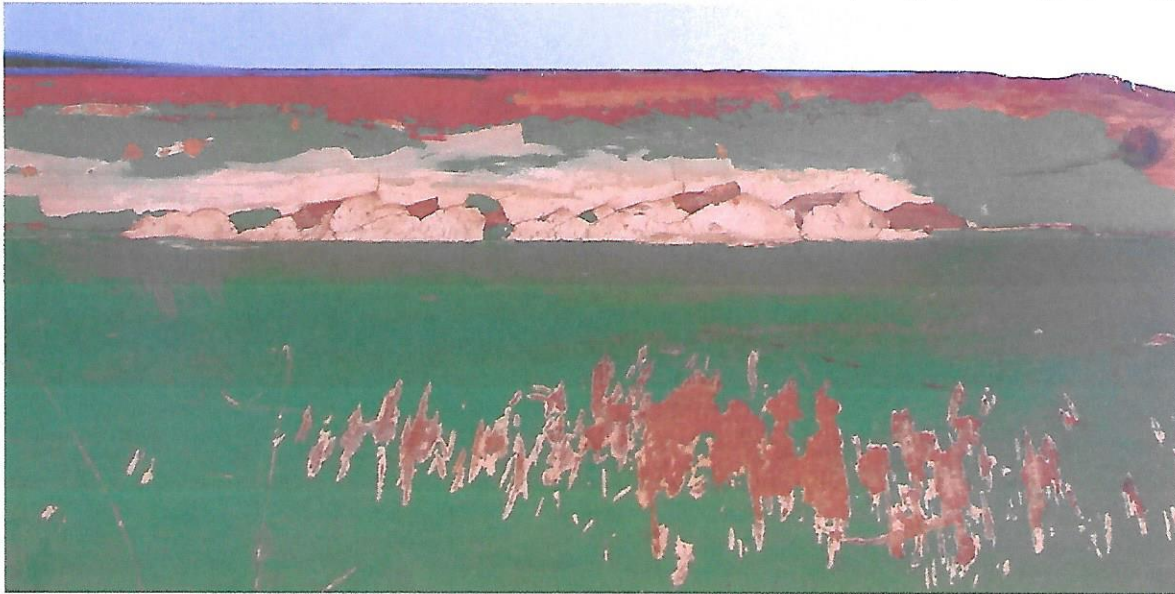
Figure 1 : Damage to fiberglass and keel.

(2) Cathy and I stripped all of the fiber glass from the bottom of the boat (see attendant photographs). In most places, the fiber glass was split, cracked, and/or fractured from being banged against rocks and other marine

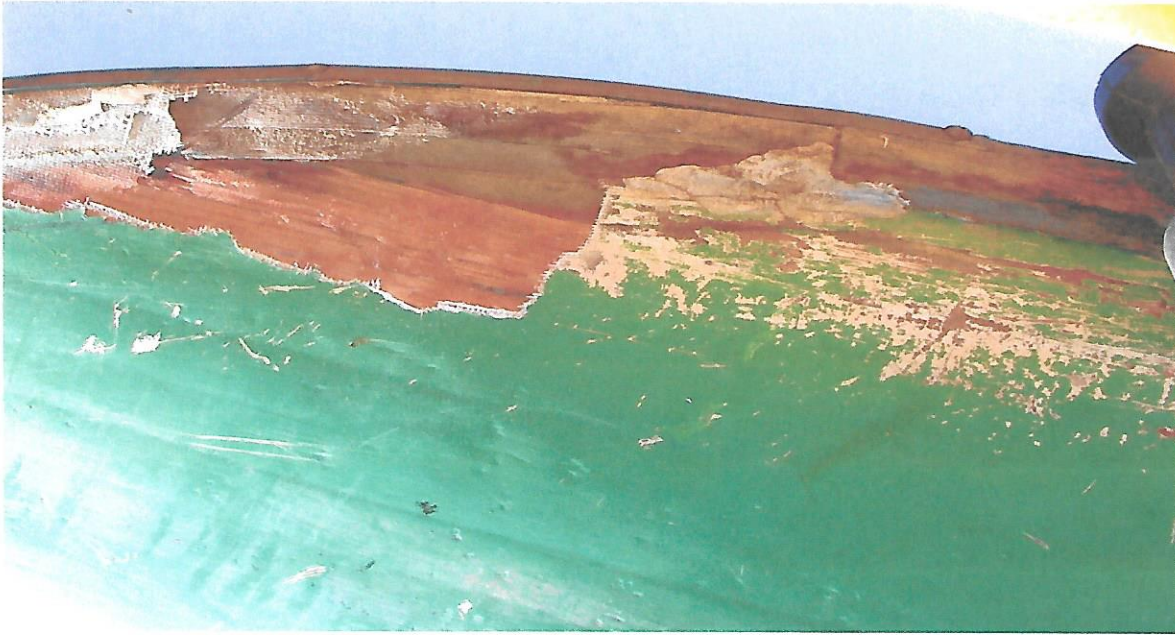
Figure 2 : Damage to bow fiberglass.
