Boars Head Revetment – Hampton, NH

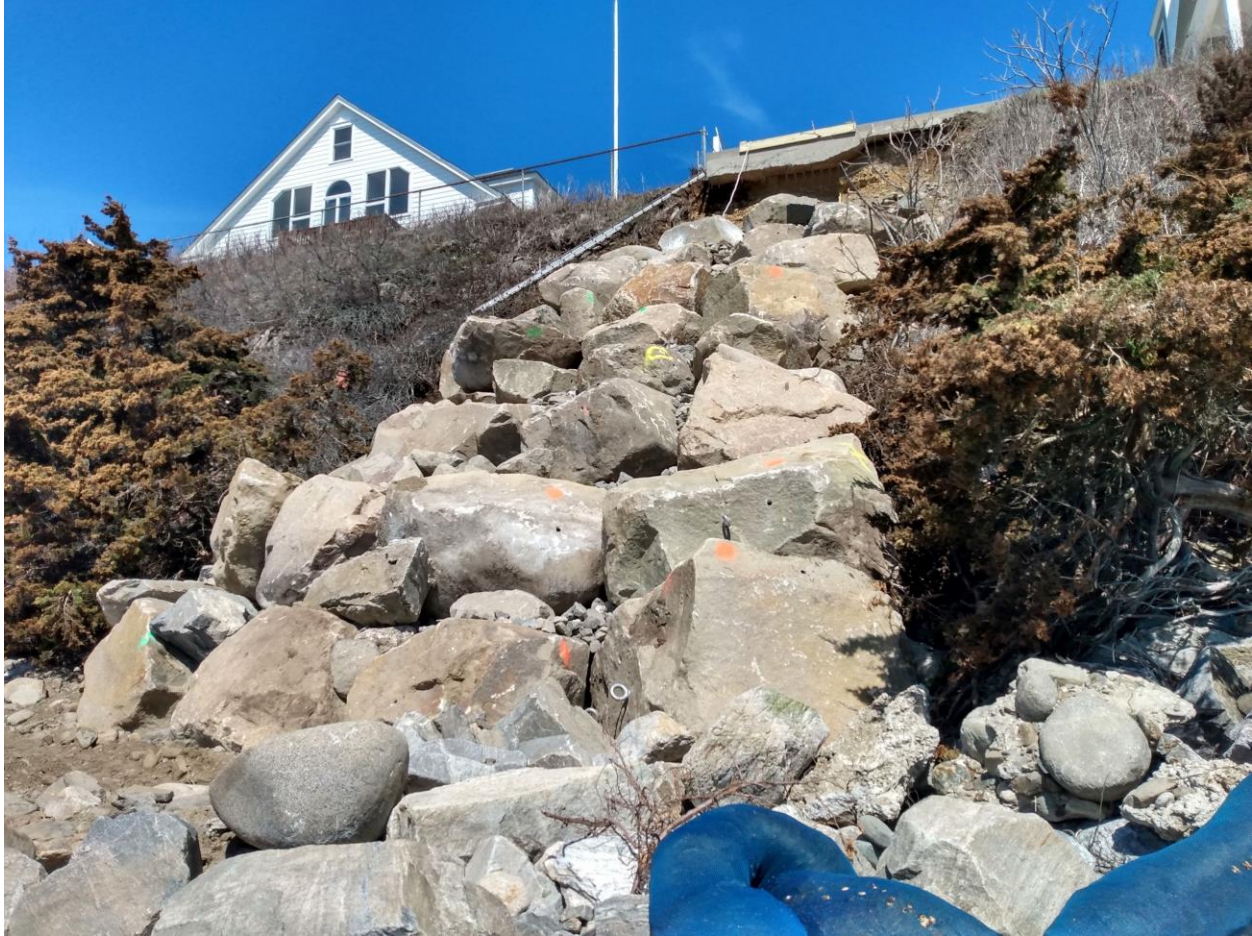
If you were driving along the New Hampshire seacoast recently, you may have seen a large crane on the outer portion of Boars Head. This Civilworks NE project was surveyed, designed and permitted to repair a slope failure on the steep 48-foot-high bluff. The toe of the bank was damaged by Hurricane Sandy wave erosion and the slope failure progressed up the bank over several years.

The repair used 4 to 10 ton armor stones that were sized for open ocean design wave conditions, transformed to a local design wave for this rocky beach. With no equipment access at the top or bottom of this slope, an excavator was lifted by crane to the base of the slope to dig in toe stones and then the revetment was constructed from the bottom to the top with the crane lifting and setting armor stones, underlayer stones and bedding stones with each course of rocks.

Due to the steep, almost 1:1 slope, that was significantly steeper than the angle of repose of planting soils, a planted slope restoration on the upper slope was not possible within the existing slope constraints.
