# LAKE SALEM 2023 FALL AQUATIC MACROPHYTE SURVEY

Report Submitted to the  
Salem Lakes Preservation Association

November 16, 2023

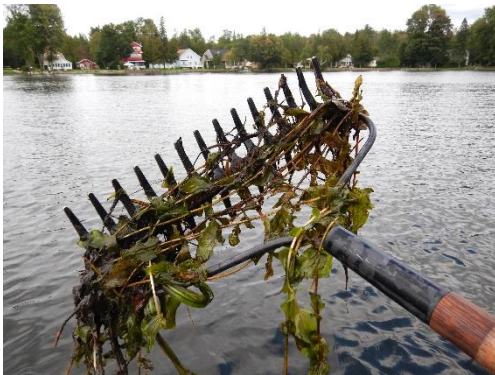
**Figure 2. Aquatic sampling rake**

An aquatic survey rake was used to gather the vegetation data at each point location. In waters shallower than 8', a rake on a pole was used to sample vegetation. In waters deeper than 8', a survey rake attached to a rope was used to sample vegetation. Rake fullness, as outlined in Table 1, was recorded for each sample to obtain information about vegetation density (Hauxwell et al. 2010; Madsen et al. 1996). Each aquatic plant on the rake was identified to species, if possible. Specimens that were difficult to identify in the field were collected and examined under a dissecting scope. Voucher specimens of many species recorded in the lake were collected and

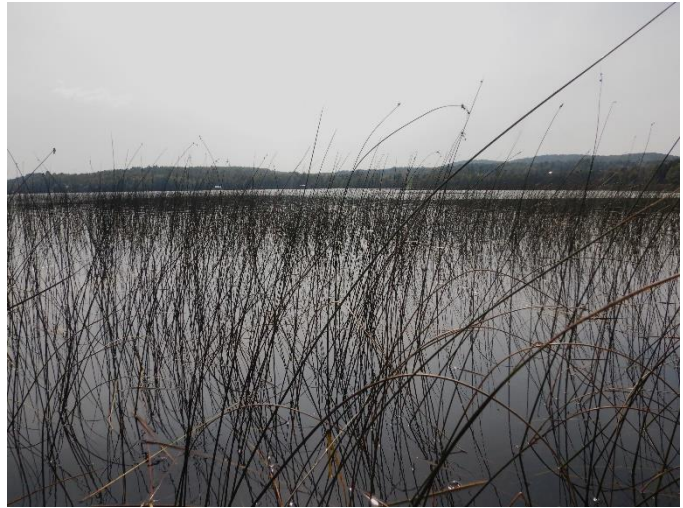
***Figure 4. Deep Bulrush Marsh Community***

The Deep Bulrush Marsh is closely related to and interspersed with the Benthic Sand Flat Community. The Deep Bulrush Marsh Community has been well-documented and occurs on the margins of lakes and pond throughout the state (Thompson, Sorenson, and Zaino 2019). It is dominated by the emergent soft-stemmed bulrush, though the closely related hard-stemmed bulrush may also be present. These plants prefer the sandy substrates found along the margins of Lake Salem. Submerged aquatic vegetation

beneath the bulrush is typically absent or very sparse. Resupinate bladderwort is found in this community, as well as scattered plants of eelgrass, stonewort or claspingleaf pondweed.

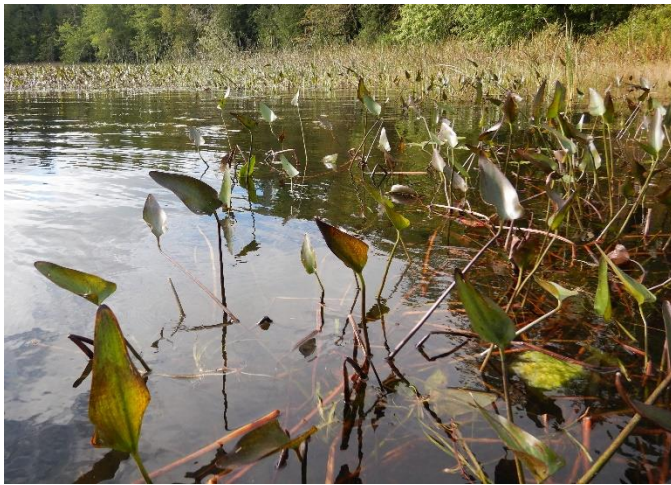
***Figure 5. Deep Broadleaf Marsh Community***

The Deep Broadleaf Marsh is closely related to and often interspersed with the Deep Bulrush Marsh Community. This community is also well-documented and occurs throughout the state (Thompson, Sorenson, and Zaino 2019). While the Deep Bulrush Marsh is dominated by the narrow-leaved bulrush plants, the Deep Broadleaf Marsh is dominated by broadleaf marsh plants such as pickerelweed and arrowhead. In Lake Salem this community

is composed largely of pickerelweed. The Deep Broadleaf Marsh is typically found on the margins of lakes and ponds in silt or muck substrates and often occurs as a narrow band of vegetation that

is transitional between the aquatic environment and adjacent wetland types such as Cattail Marshes. In Lake Salem, the community has been mapped at two locations in the southwest and northwest corners of the lake. In these areas, though the substrate is mostly sand, the vegetation has the effect of mitigating the impacts of wave action and trapping finer sediments. While only two occurrences have been mapped in the Lake, pickerelweed and small areas of this community are often found interspersed with the Deep Bulrush Marsh.

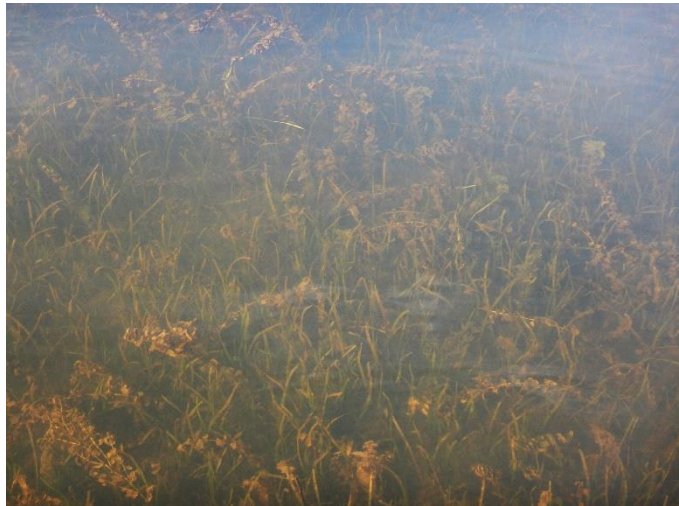
**Figure 6. *Eelgrass-Claspingleaf Pondweed Community***

This aquatic community has been documented in Lake Memphremagog and Lake Champlain, where it is very common, forming extensive beds covering hundreds of acres (Arrowwood Environmental and Lake Champlain Committee 2013). The community is dominated by eelgrass and claspingleaf pondweed. Stonewort can also be sub-dominant in some areas. Other species include water stargrass, waterweed, water naiad, and Robbin's pondweed. The percentage cover of vegetation in this community can reach 100%. However, localized areas with very little vegetation are also present. This community type is found throughout Lake Salem in areas ranging from 2 to 15 feet of water.

This community occurs in the locations most suitable for aquatic plant growth, and

therefore has the highest plant species diversity. The submerged vegetation can grow quite tall, in some cases reaching the water surface. This community provides the most suitable habitat for EWM in the Lake. These areas, therefore, are where the densest infestations of EWM are likely to occur. In addition to high species diversity, most of the vegetative biomass of the lake occurs in this and the Water Lily Aquatic Community (discussed below). Because of the high plant species diversity and abundance, these locations provide high quality habitat for aquatic life, including a wide array of benthic organisms and fish in most stages of their life cycles.

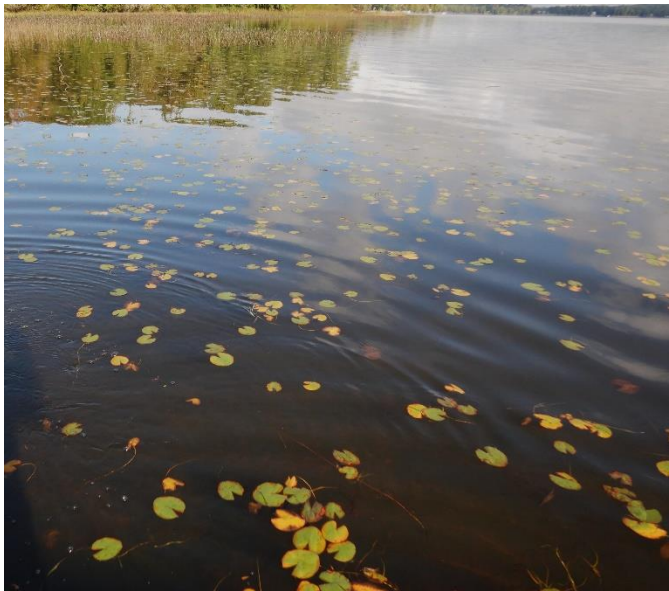
**Figure 7. Water Lily Aquatic Community**

This community is dominated by the presence of floating-leaved aquatic species such as water lily. This is a well-documented community found throughout the region (Gawler and Cutko 2010; Hunt, Anderson, and Sorenson 2002). This community is typically found where the water is shallow and there is a significant layer of organic muck substrate. This can occur in the sheltered bays of large lakes or throughout the littoral zones of small lakes and shallow ponds. In these areas, the cover

of the floating-leaved species can completely cover the water surface. In Lake Salem, however, this community is not found in the typical locations but primarily along the western shore in areas 2-4 feet deep with a layer of silt over sand. Under these conditions, water lily is present, but because it is not preferred growing conditions for this species, the abundance is only in the 10-50% range. Submerged aquatic vegetation below the water lily consists of eelgrass, claspingleaf

pondweed, waterweed and stonewort. Percent cover of submerged vegetation is highly variable, ranging from 5%-100%. In Lake Salem, this community is very similar to the Eelgrass-Claspingleaf Pondweed Community in terms of species composition, diversity and biomass and in many areas, these two communities intergrade. Analysis of aerial imagery indicates that the distribution and abundance of water lily varies from year to year.

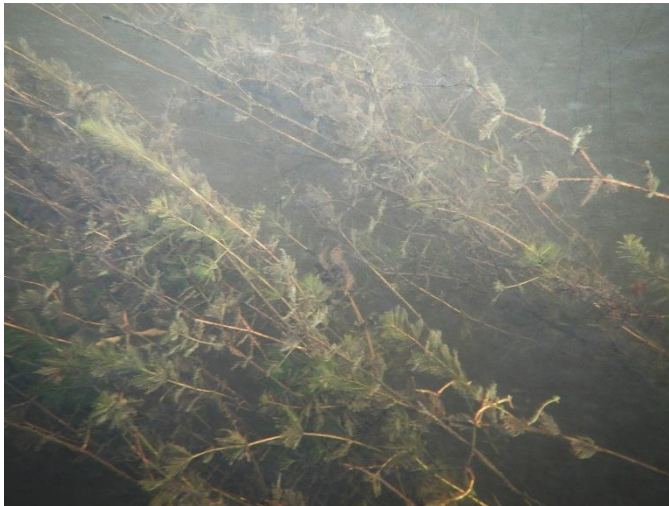
**Figure 8. Eurasian watermilfoil**

One species of NNIS was documented in one area during the current inventory: Eurasian watermilfoil (EWM). Due to wind and waves during the field inventory, visibility was somewhat limited. There is, therefore, the possibility that single individuals of EWM (especially if they were well below the surface of the water) may have been present but not detected. The area of EWM documented during the inventory is shown on the map in Appendix 2. This area is approximately 0.13 acres (5662 square feet). Overall, the percent cover of EWM in this area was approximately 10%. However, there were some localized patches that were much denser, in the 75%-100% range.

Most of the milfoil plants were senescing and/or impacted by the herbicide application. Examination of specimens revealed that some plants may be hybrids between EWM and the native milfoil (*Myriophyllum sibiricum*). Positive identification of hybrid plants requires examination of leaves from the middle of the stem (Moody and Les 2007). Since many of these leaves were senesced at the time of the site visit, this identification

should be considered provisional. The presence of hybrid milfoil individuals may be significant

because these plants have been known to be more resistant to ProcellaCOR herbicide than non-hybrid EWM plants (Glisson and Larkin 2021) .
