Electric Panel inside each unit (kitchen)

The bottom line, our existing electric panel cannot bear any additional appliances.

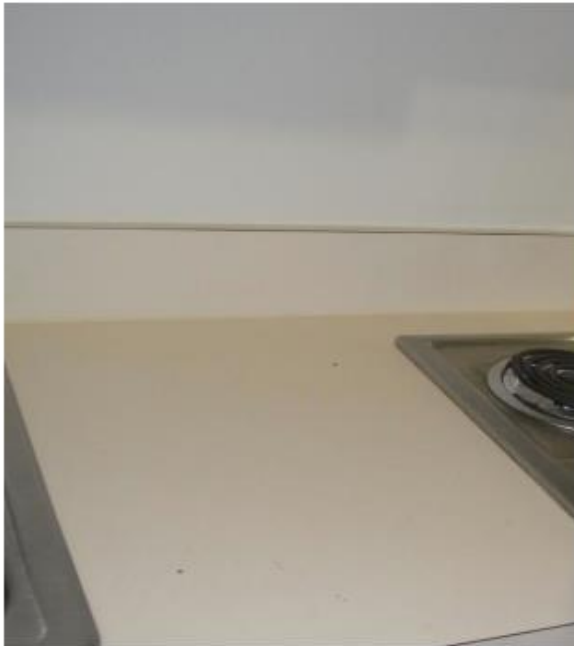
wider be provided with a GFCI outlet. There were many instances of this violation. An example from apartment 222 is shown in figure 7.

Figure 7. Kitchen counter wider than 12",
Missing a GFCI outlet.

The electrical system for the facility is on fair condition and consistent with the age of the facility. There are several locations we noted that were in violation of the NEC. These include exposed wiring, missing covers and rusting. Also, the required GFCI receptacles need to be provided. The 120 volt circuit breakers should be replaced with arc-fault type breakers. All receptacles should be replaced with tamper-proof receptacles. There should be a development of a maintenance procedure to improve the condition of the electrical system.

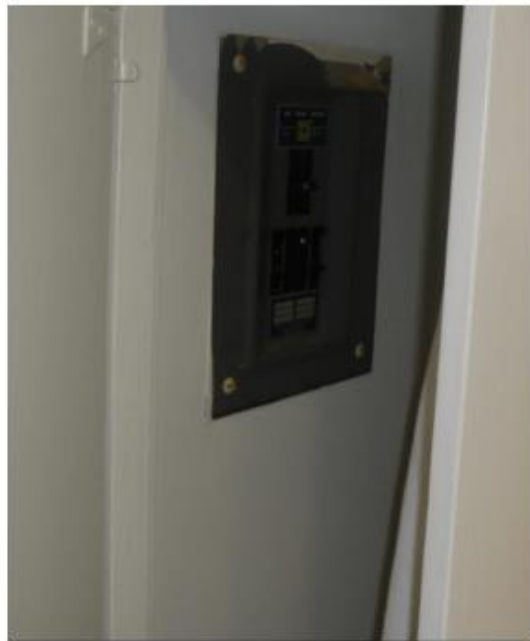
Figure 8. Load Center Location.

Another violation is that the load center is located in a closet that does not provide the required clearances. The load center is located on a side wall of a closet that is 24 inches wide. The NEC requires a clearance in front of the load center of a minimum of 36 inches. See Figure 8.

Further, to become compliant with the present NEC, the load center will need to be upgraded to provide for additional circuits. As a minimum, there needs to be **two kitchen small appliance circuits, a bathroom circuit with no other loads, a refrigerator circuit, a range circuit and a lighting and power circuit, or a minimum of 7 circuits. The existing load centers have 6 circuits.**
