Florida Building Inspection Group PO Box 1633 Riverview, FL 33568

SUMMARY ROOFING EXTERIOR STRUCTURE ELECTRICAL HEATING COOLING INSULATION PLUMBING INTERIOR

SUMMARY Report No. 21885

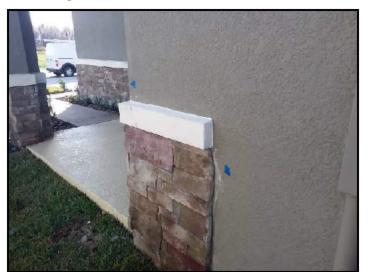
8. Paint touchups

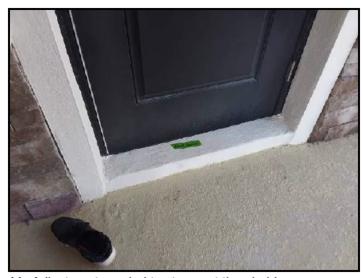
11. Adjustment needed to stucco at threshold

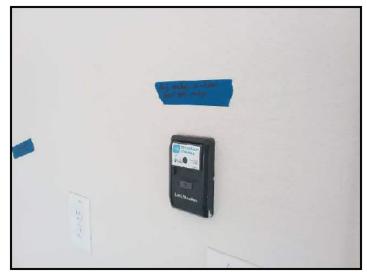
16. Adjustment needed to garage door

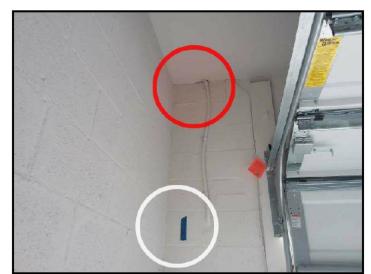
17. Sealant needed

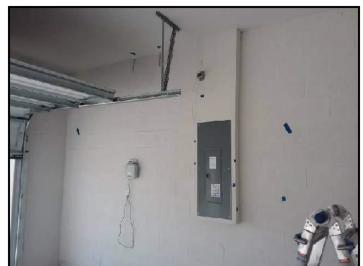
23. Sealant needed

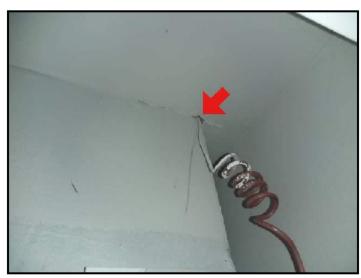
33. Sealant needed around plenum on inside

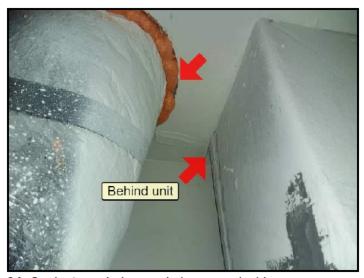
34. Sealant needed around plenum on inside

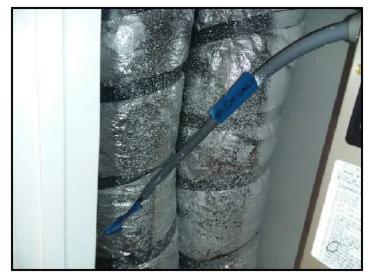
35. Conduit needed - must be complete to wall

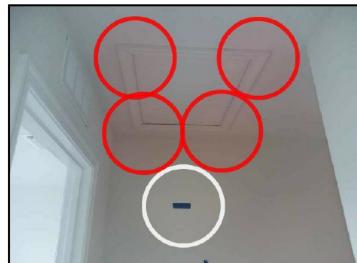
36. Seam in carpet

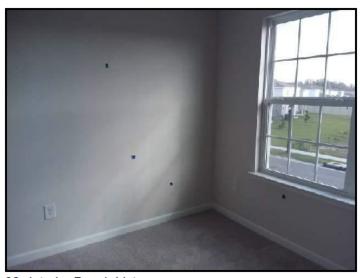
37. Exposed finish nails on trim

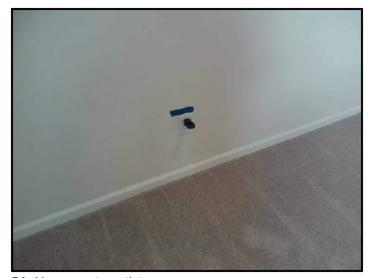
54. No power to outlet

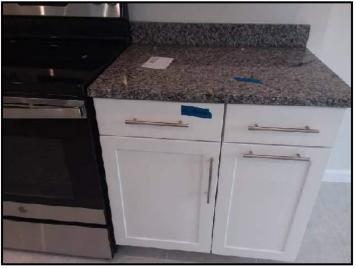
61. Adjustment needed

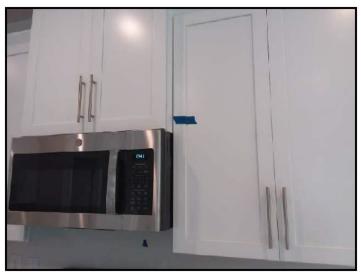
62. Adjustment needed

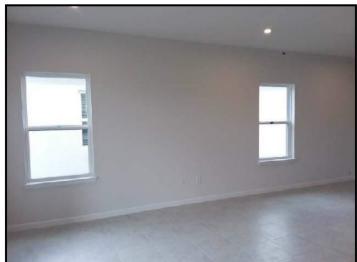
69. Stiff/adjustment needed

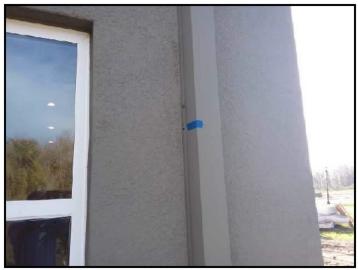
91. Seal hole

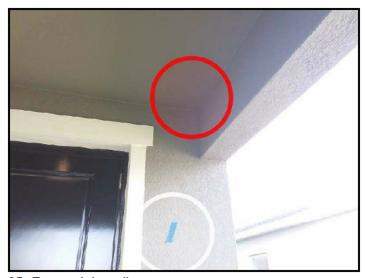
95. Exposed drywall screws

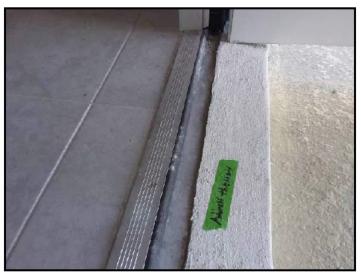
98. Adjustment needed to stucco at threshold

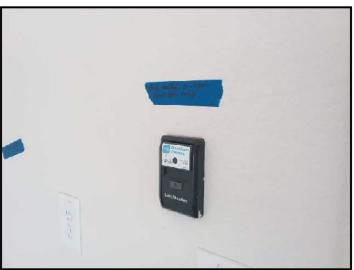
102. Adjustment needed to garage door

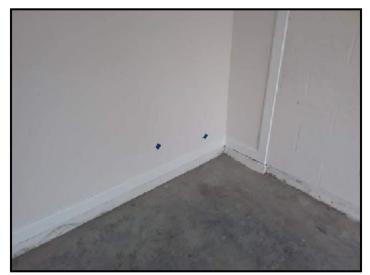
105. Paint touchups

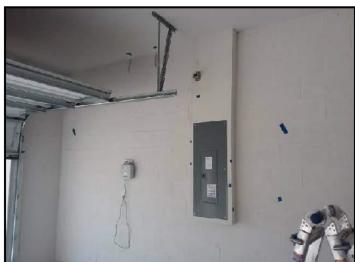
109. Sealant needed

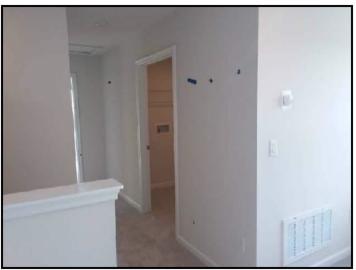
143. Interior Punch List

Majority of items noted are either Paint (blue tape) or Drywall (green tape) touchups or repairs unless specifically noted.

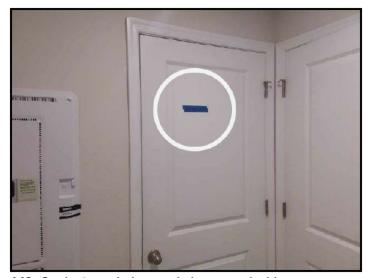
148. Sealant needed around plenum on inside

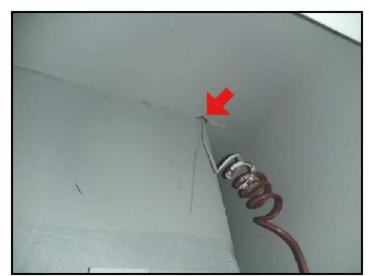
149. Sealant needed around plenum on inside

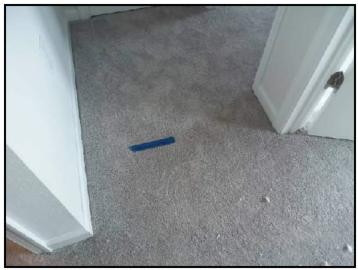
152. Seam in carpet

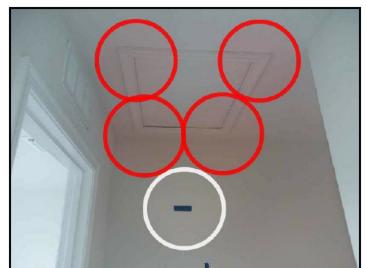
153. Exposed finish nails on trim

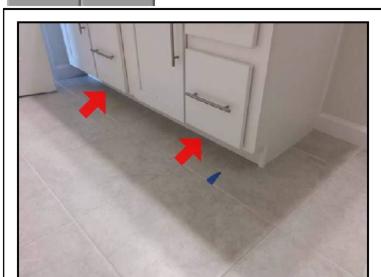
161. Grout cracking

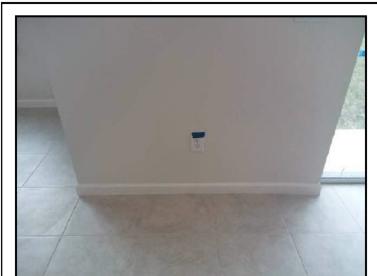
174. Loose outlet

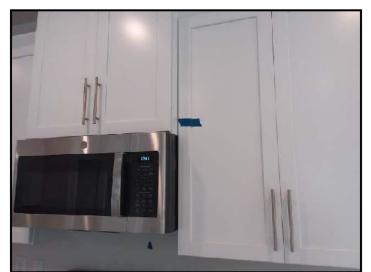
178. Adjustment needed

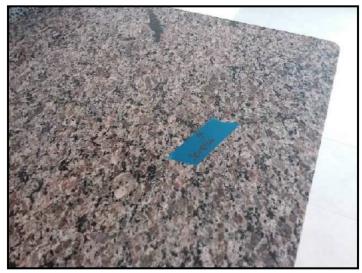
179. Scratch
